ARARIRA / LII CATCHMENT: HYDROLOGY, ECOLOGY AND WATER QUALITY

Report Number: 1414458_7410-003-R-Rev2

NOVEMBER 2015

The scope of this report is to describe the hydrology, water quality and ecology of the Ararira / LII River catchment, to identify environmental enhancement opportunities, and to provide monitoring recommendations.

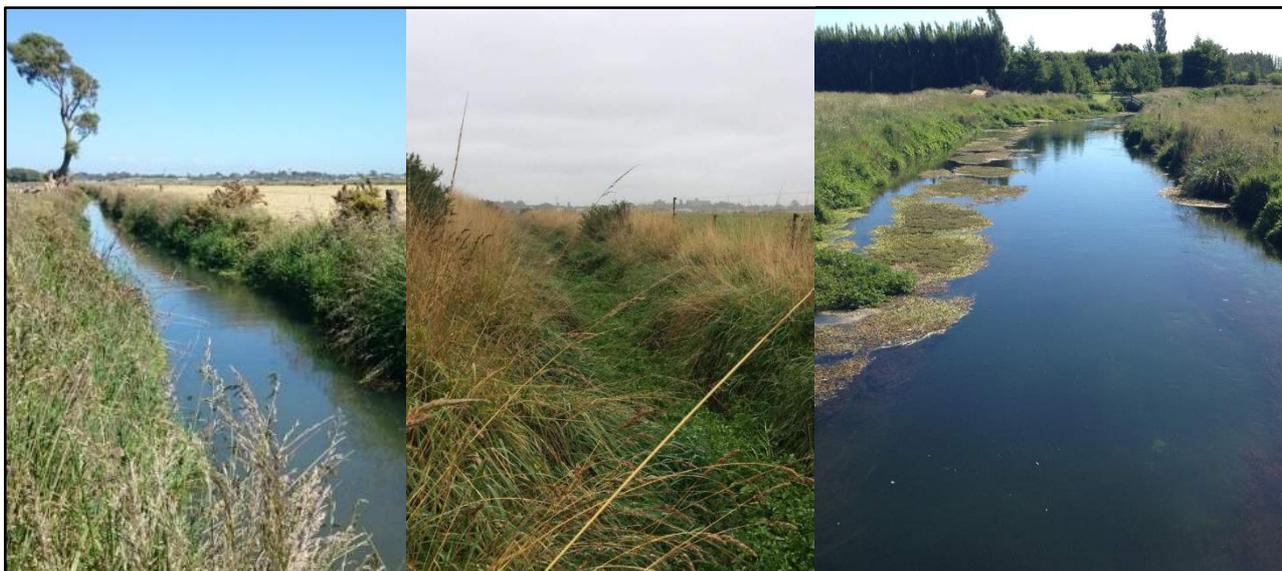
Figure 4: Typical Ararira / LII River waterways: Springs Creek (left); Lincoln Main Drain (centre) and Ararira / LII below Englishs Road (right), note rectangular cross section and low velocities.

The hydrology of the Ararira / LII River catchment is well understood and is based on an extensive set of records from within the catchment. The Ararira / LII River is a major contributor of flow to Te Waihora / Lake Ellesmere and has the highest low flow⁸ and mean flow contributions and only the Selwyn River contributes a higher annual volume to the lake. The hydrology of the Ararira / LII River catchment is dominated by the influence of groundwater and Te Waihora / Lake Ellesmere. Control of the lake's level and land drainage works throughout the catchment have significantly altered the area's hydrology. Prior to these alterations groundwater level was high throughout the catchment and wetlands extended from the lake to the outskirts of Lincoln. Most of the indigenous hydrology of a large wetland has been removed by a drainage network to support agricultural development. Current hydrology is dominated by low velocity channelized flow along mostly straight, homogeneous drains and channels (Figure 4).

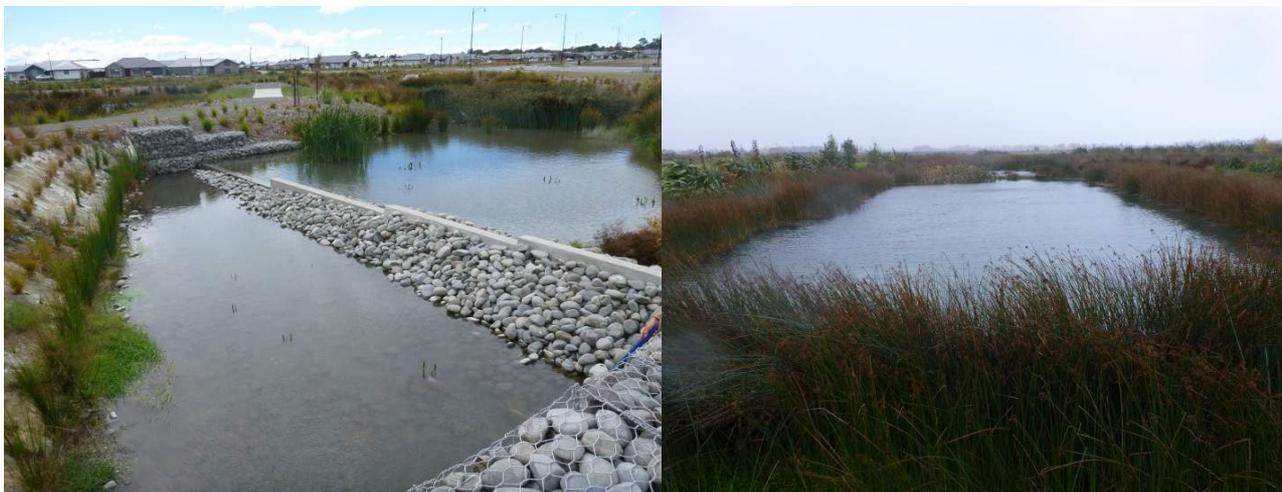
Figure 8: Constructed wetlands near Lincoln township.

Within the catchment, the surface hydrology reflects a highly altered state with significant agricultural impacts. The extensive drainage network maintained by the SDC, LII Drainage Committee, and private landowners serves to lower the groundwater table and convey water via mostly straight, homogeneous channels that were constructed for development purposes (few waterways within the Ararira / LII River catchment have natural alignments or characteristics). The main stem of the Ararira / LII River widens as it approaches the lake, but it too has been straightened, improved, and maintained for drainage purposes. Due to the natural flat topography of the land, many waterways have low flow velocities, resulting in very limited bed movement or scour. As a result silty sediment, which occurs naturally in the catchment¹² but is aggravated by development, accumulates in the waterways until mechanically removed. Terrestrial and aquatic plants grow near / in the waterways and rapidly colonise areas of deposited sediment until removed by weed cutting activities. Pockets of wetlands similar to the indigenous condition of the catchment are still present as at some spring locations e.g., Yarrs Lagoon, and at the river mouth. Recent stormwater management features near Lincoln township have included development of wetlands to manage flow discharges and filter out contaminants (Figure 8).

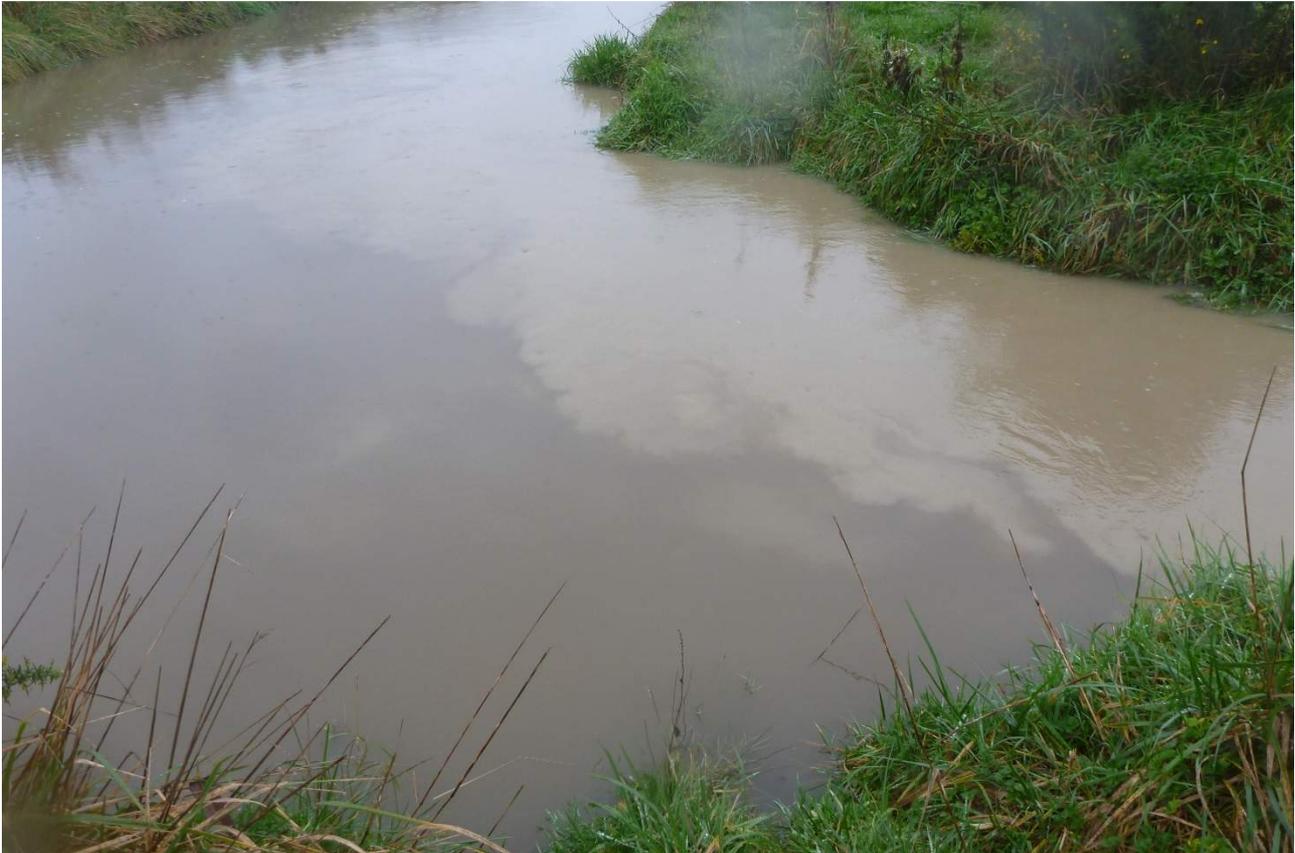
Figure 14: Tributaries can be major sources of sediment, especially during rainfall events.

Similar to this study, Serriere et al. (2012) observed a similar marked increase in turbidity in this area of the catchment following rainfall (between the confluence of the LI Creek and Liffey Stream downstream to the confluence of Springs Creek with the mainstem), with turbidity decreasing in a downstream direction from this point. The current data from this study, combined with the findings of Serriere et al. (2012) and EOS Ecology (2014), suggest that suspended sediment inputs to the mainstem are principally sourced from tributaries in this general area (Figure 14).

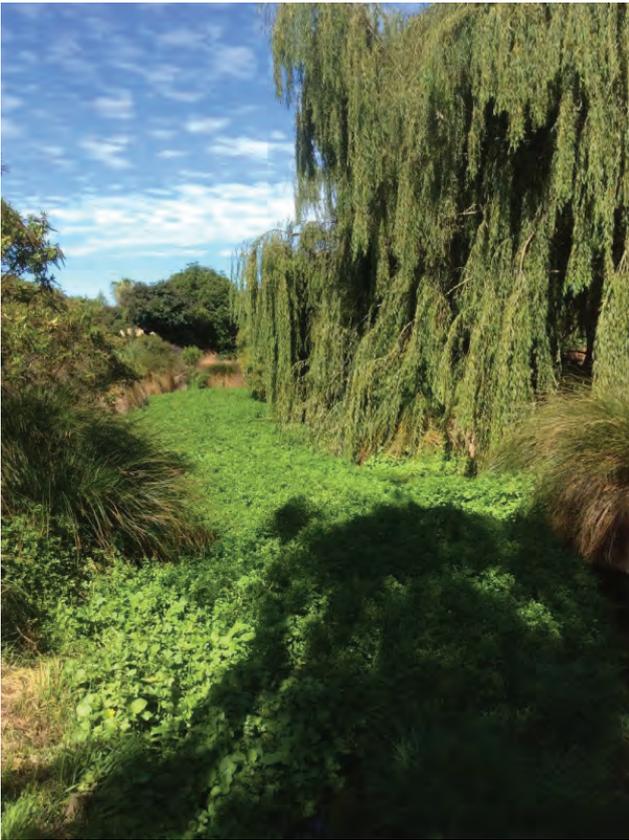
Emergent macrophytes were abundant in many tributary reaches

Macrophyte communities in the mainstem are generally dominated by submerged species, as most reaches are too deep for emergent macrophyte growth, apart from the banksides. The most common species recorded in the mainstem during the stream walk surveys were exotic Canadian pondweed and curly-leaf pondweed and native water milfoil. Patches of native charophytes were often intermixed within these submerged macrophytes. There were a few localised areas of other native macrophyte species, such as fennel-leaf pondweed, particularly in the lower reaches of the mainstem by Te Waihora / Lake Ellesmere. Fennel-leaf pondweed is one of several species being considered for macrophyte restoration as part of the Whakaora Te Waihora programme. Emergent macrophytes are generally more abundant in the smaller tributary waterways, particularly in the least shaded reaches. Many tributaries have large sections that often become covered by emergent macrophytes. The two main emergent species present are monkey musk and watercress (Figure 16).

Many of the Ararira / LII River tributaries are straightened, channelized, soft-bottomed waterways. These waterways generally have steep-sided banks, and consist mainly of run habitat with occasional stagnant areas resulting from abundant emergent macrophyte (aquatic plant) growth (Figure 16). There are, however, a few larger tributaries in the upper catchment that have a more natural, sinuous channel form (at least in certain sections). These include the LI Creek, Liffey Stream and Springs Creek. Stony substrate is rare in most tributaries, and is restricted to the mid to upper reaches of Powells Road Drain, Goodericks Drain, Liffey Stream, and the LI Creek. Springs occur in many tributaries, especially those in the upper catchment (e.g., Springs Creek).

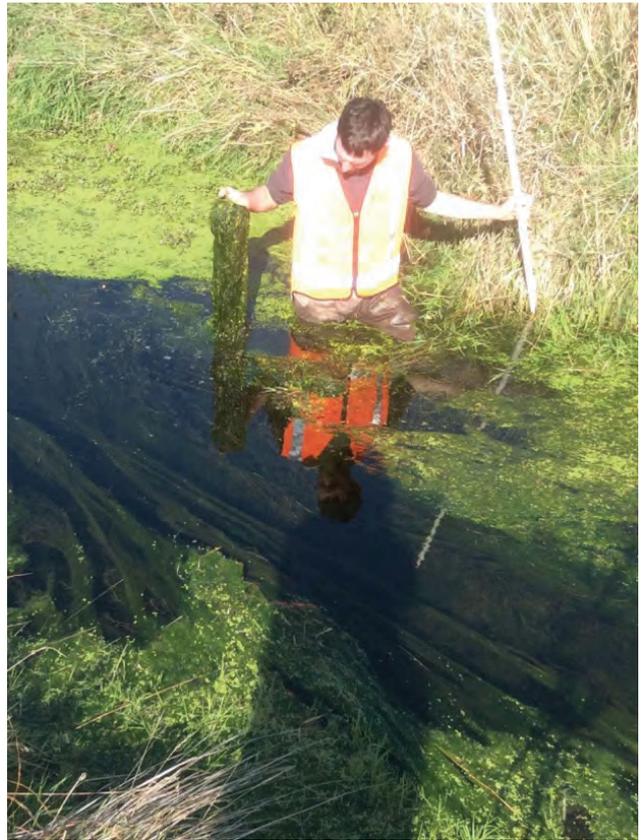
High filamentous algal cover

Periphyton (algae that attaches to stream beds and other surfaces) biomass can become high in some waterways, particularly in the unshaded sections of the channelized tributaries (Figure 16). Long filamentous algae were the most commonly observed algal group during the stream walk. However, as is the case with other Te Waihora / Lake Ellesmere tributaries, macrophytes are more visually dominant than periphyton in most waterways (Kelly 2014). The toxic cyanobacterium *Phormidium* was also observed at a single site from the upper Liffey Stream during the surveys. *Phormidium* is found in a number of Canterbury lowland rivers; it is highly toxic to dogs and may also be harmful to humans.

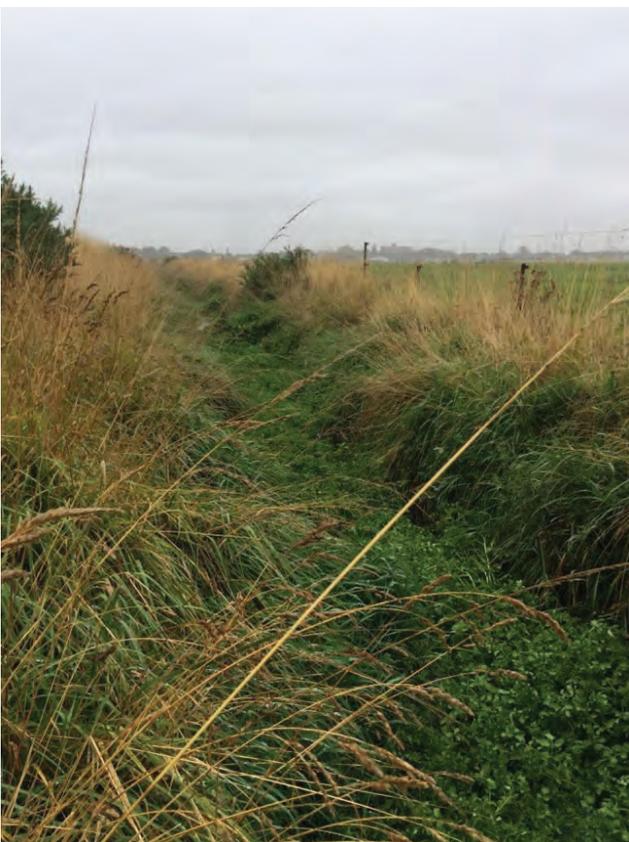
Typical bank-side vegetation of many tributaries

fencing was within 3 m of the waterway. The majority of riparian margins, especially for waterways flowing through agricultural land, comprise mainly of exotic rank grasses (tall fescue, creeping bent, amongst others), dock, willow weed, with the occasional patch of gorse, and blackberry (Figure 16). Tributaries that flow alongside roads have a grassy buffer strip as part of the roadside reserve, which contain little if any woody vegetation. The most common trees within the riparian margins include willows (mainly crack and grey), gums, poplars, elder, alder and ornamentals (oak, sycamore and silver birch).

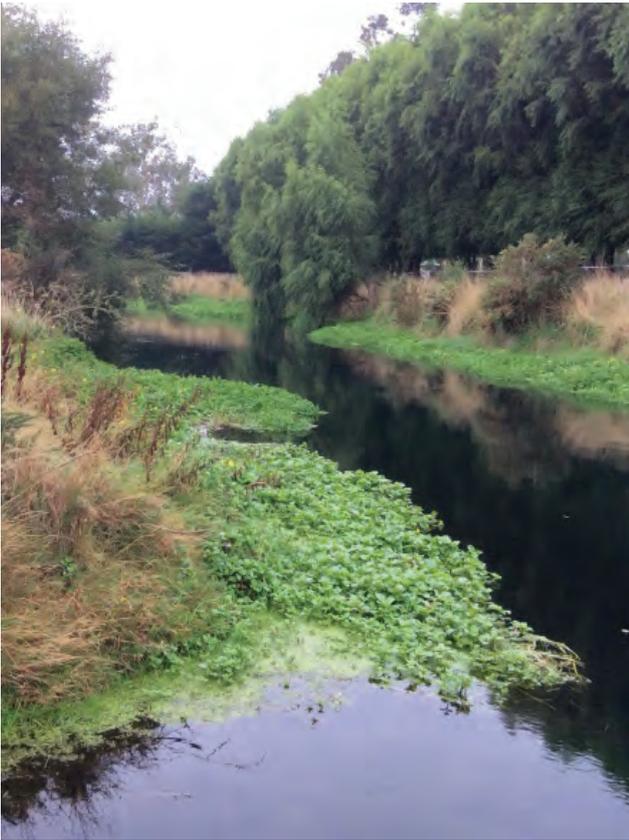
Typical run habitat, which is the dominant flow habitat type for the catchment

The Ararira / LII River mainstem consists mainly of run¹⁸ habitat with a soft-bottomed substrate dominated by silt and sand (Figure 17). Exposed stony substrate is virtually absent from the mainstem, apart from a few isolated sections near Englishs Road in the middle reaches, and around a number of road bridges (e.g., Pannetts Road Bridge) (Figure 17). The Ararira / LII River channel has low sinuosity (i.e., meanders) along most of its length, with many reaches having been historically straightened and channelized (e.g., through Yarrs Lagoon). These activities, as well as macrophyte removal operations, have resulted in it being predominantly channelized with a rectangular cross section.

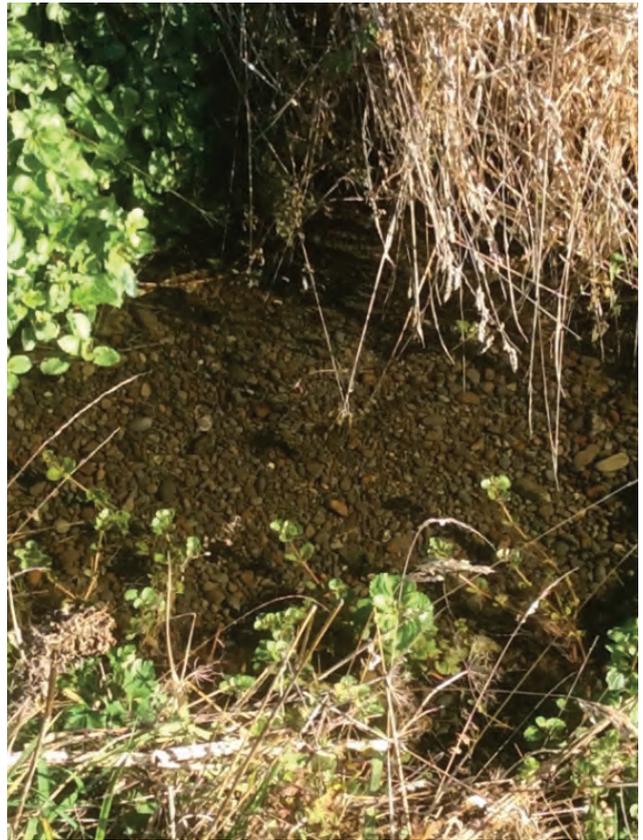
Exposed gravel substrate like this is rare in the catchment

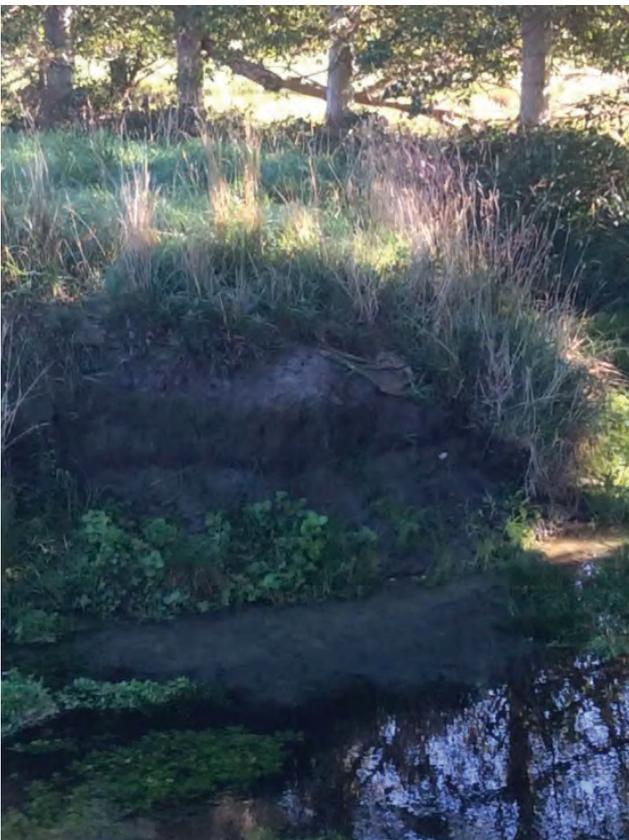
Bank slumping and erosion on the mainstem

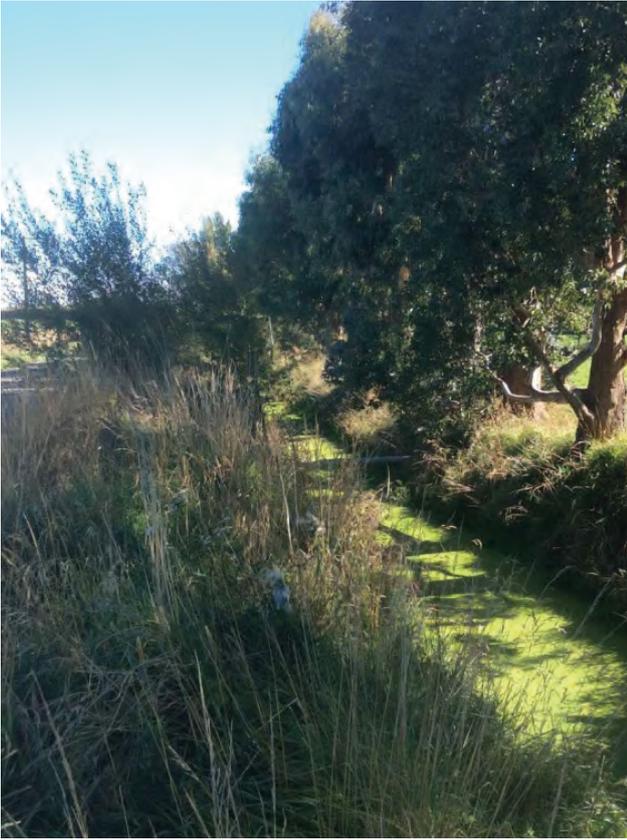
Typical tributary habitat

Tributaries, like the mainstem, are subject to periodic channel maintenance and macrophyte clearance (Figure 18) that result in extensive channel downcutting, over-steepening of the banks and reduced bank stability. Stream bank slumping, which is likely to be primarily attributable to such activities, was observed in many of these waterways during the stream walk survey (Figure 18). In addition, bed substrate is often removed from the beds of many of these tributaries as part of maintenance activities (Figure 18).

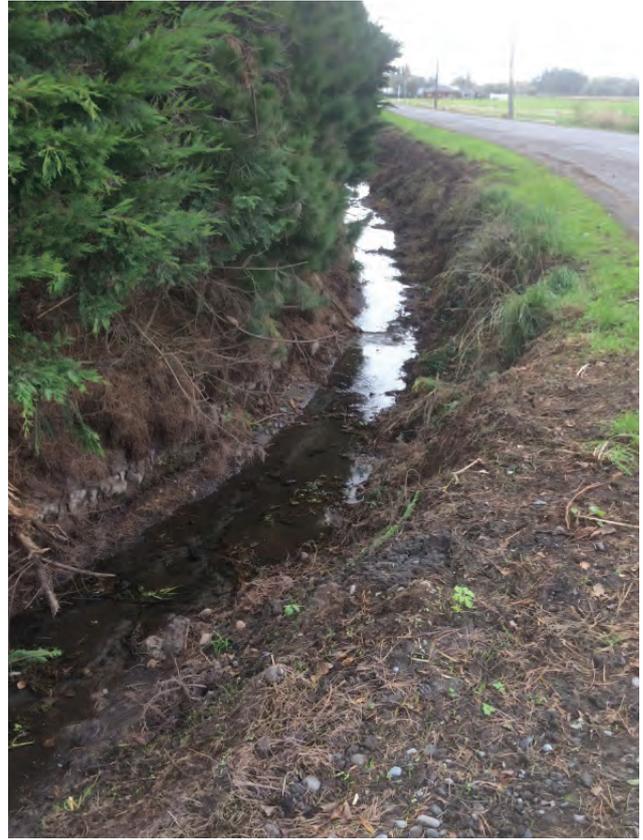
Drain condition immediately following drain maintenance

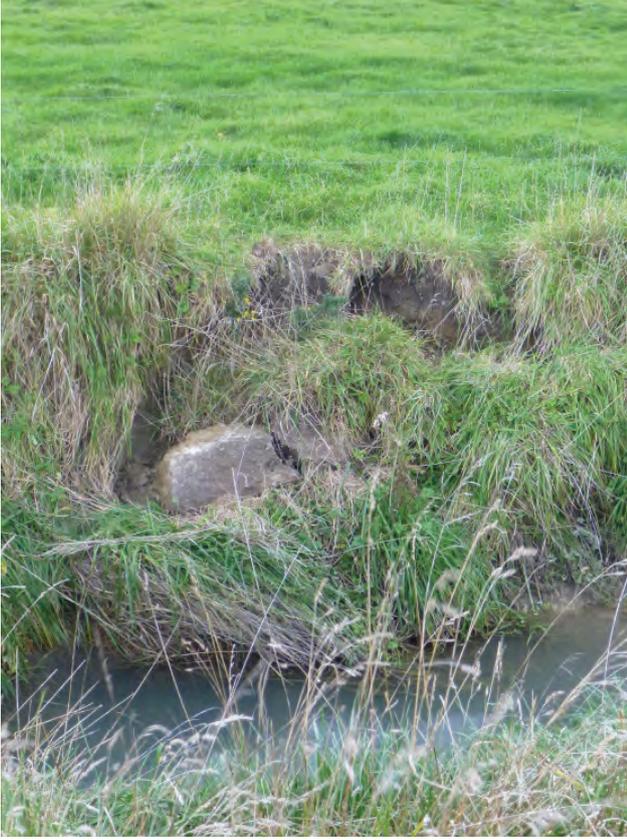
Stream bank slumping observed during the surveys

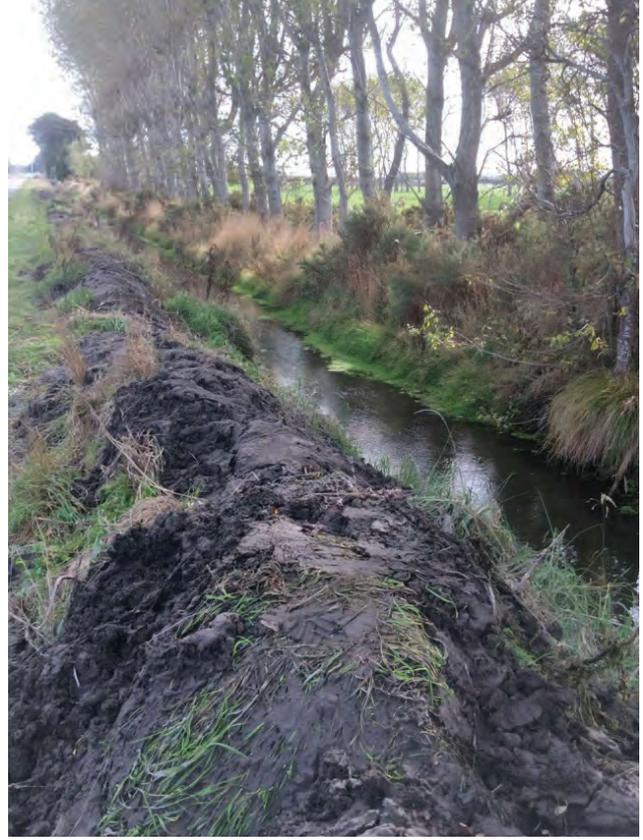
Bed (and bank material) substrate removed during drain clearing

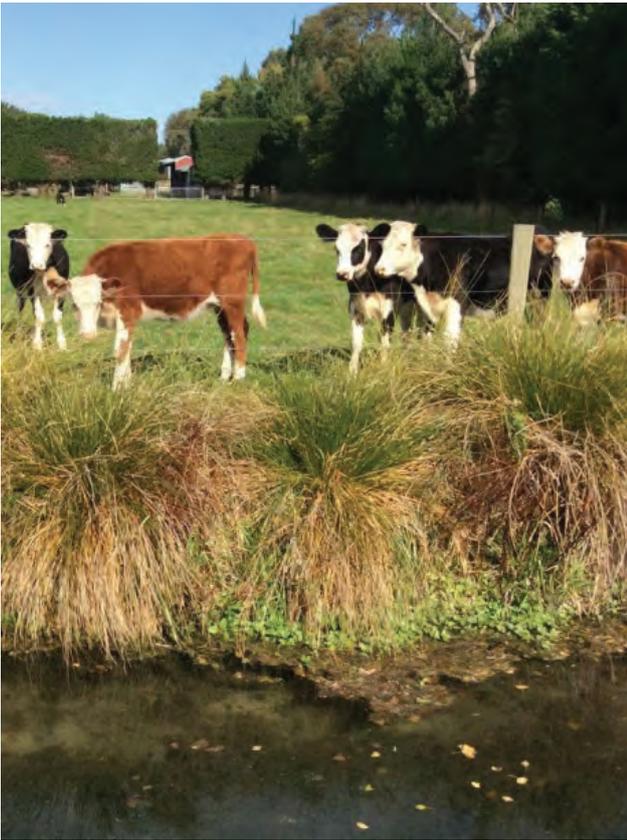
Well-fenced and planted riparian margin

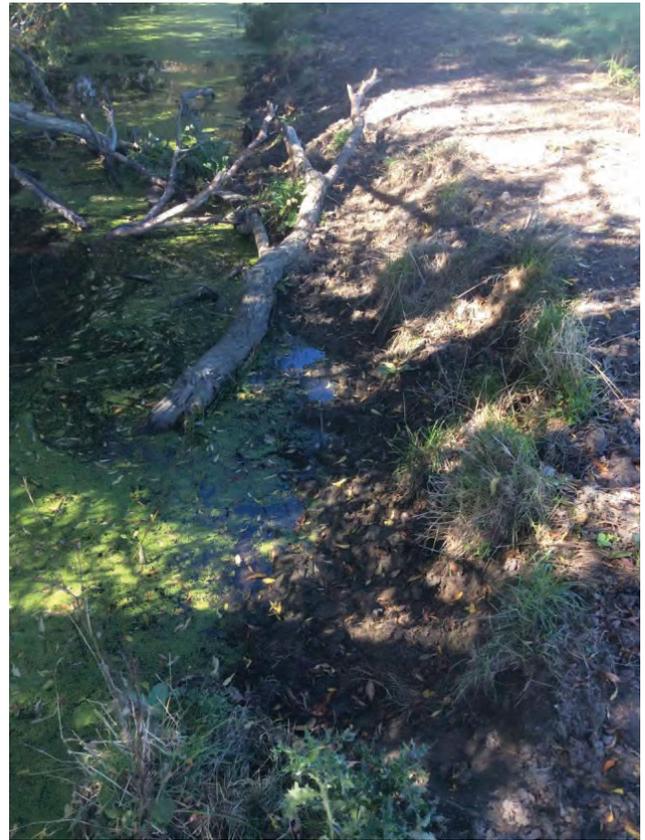
Complete lack of fencing and obvious stock damage

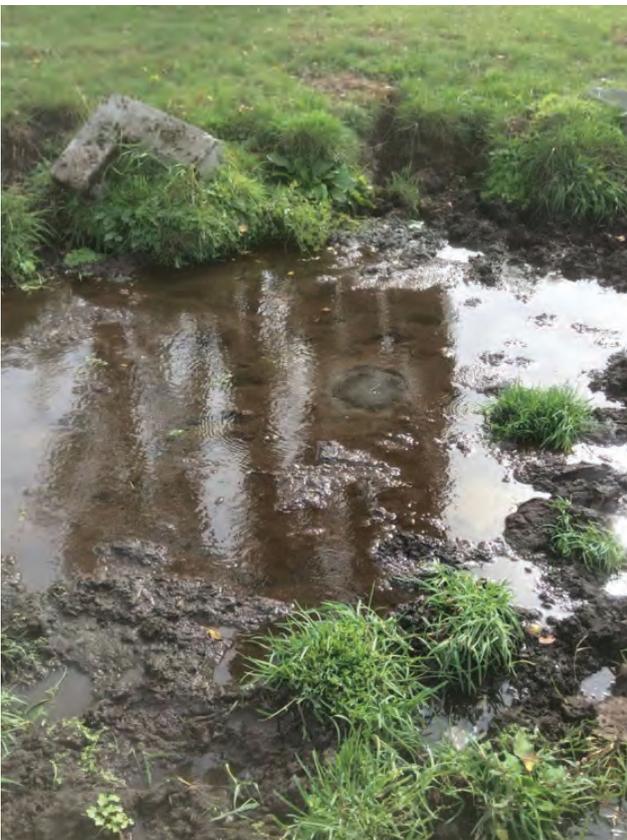
Stock damage surrounding a spring source

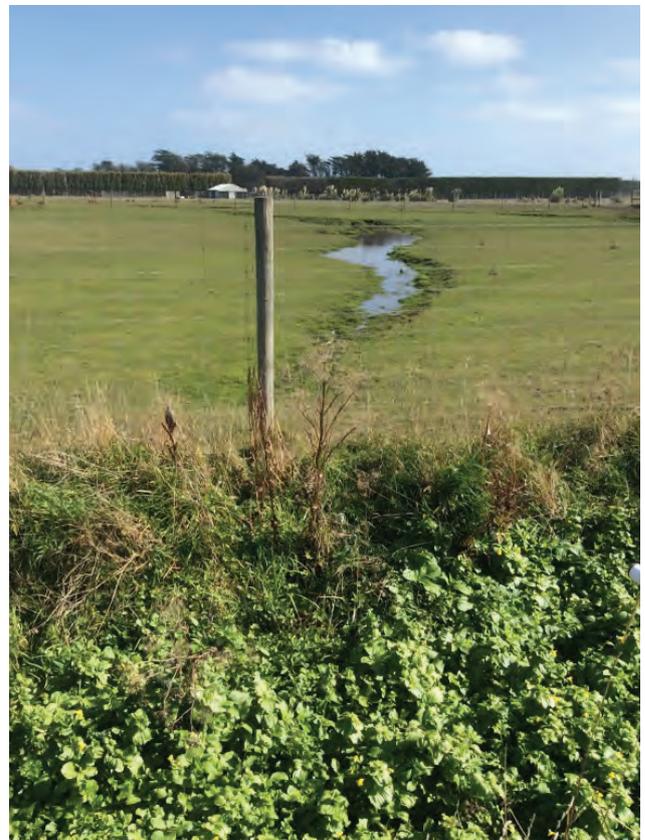
Lack of fencing on ephemeral waterways

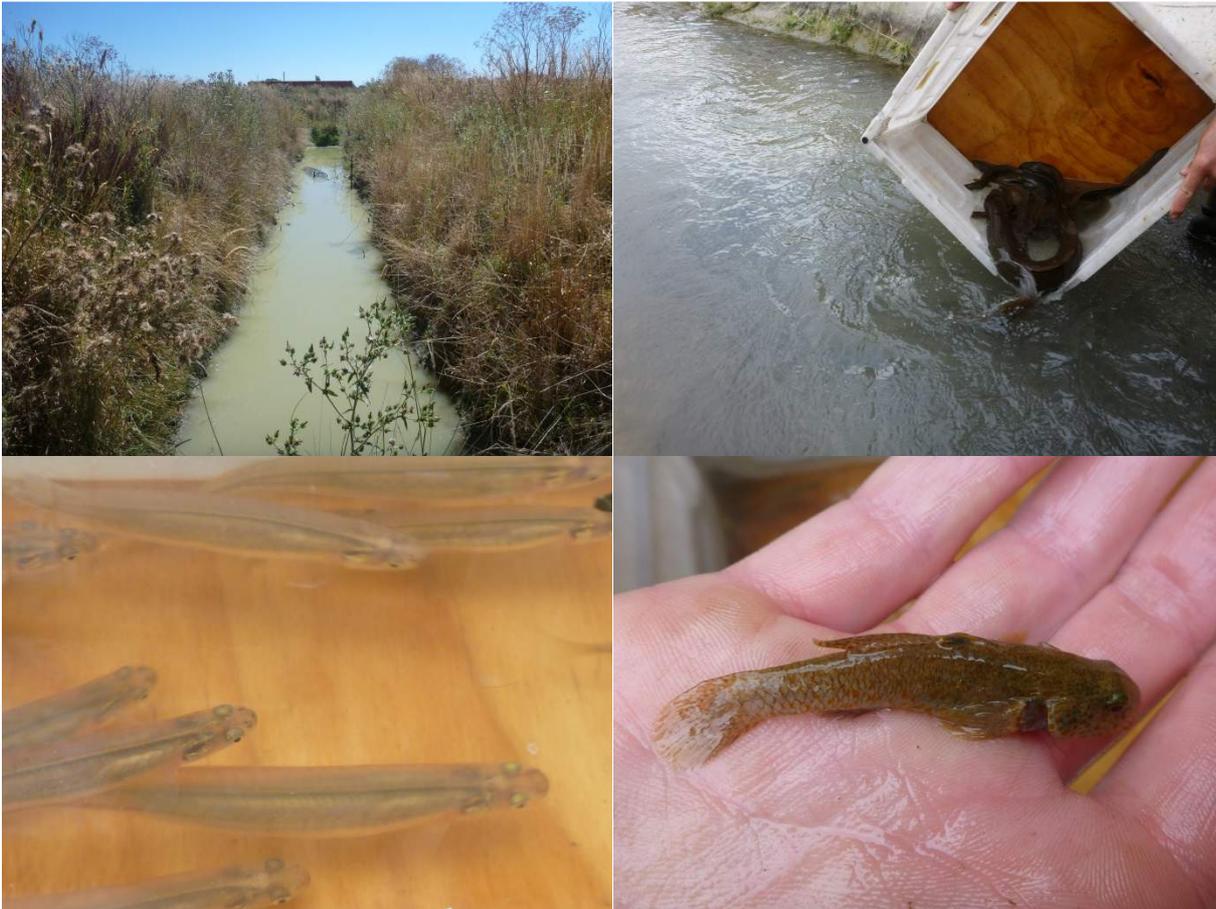
Figure 21: Recent fish relocation from a tributary waterway near Lincoln township.

First impressions of tributary waterways such as these on the top left may suggest that they have very limited ecological value. However, a recent fish relocation operation in February 2015 from a 70-m section of waterway turned up a total of 145 fish: 33 of which were eels (top right), 57 were inanga (bottom left), and the remainder were bullies (bottom right).

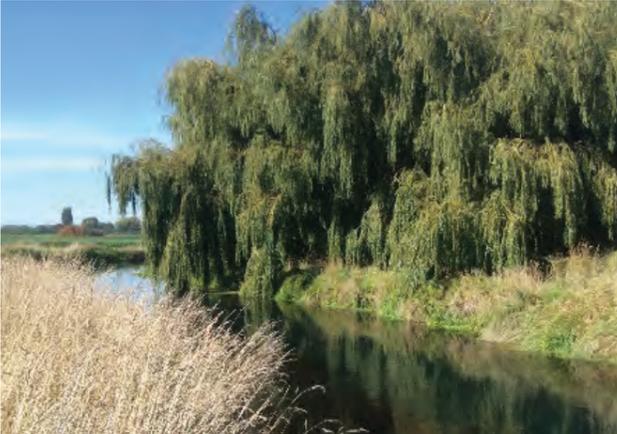
<p>Current state:</p> <ul style="list-style-type: none"> Run habitat. Generally quite deep (>1.5 m water depth), with average wetted width ranging from 8 – 10.4 m. Predominantly soft-bottomed; however, localised patches of gravel / pebble areas present that are heavily embedded with fine sediment. Bank vegetation dominated by rank grasses; little tall woody riparian vegetation. Channel shading low. Mostly moderate-angled stable banks that are partially fenced. Six erosion / slumping hotspots observed. High cover of submerged macrophytes (70 – 90 %) – dominated by Elodea, Potamogeton and Myriophyllum. Springs observed in reach 2. <p>Potential enhancement options:</p> <ul style="list-style-type: none"> Riparian planting for channel shading, habitat, biodiversity value, and bank stabilisation.
Wolfes (mainstem)

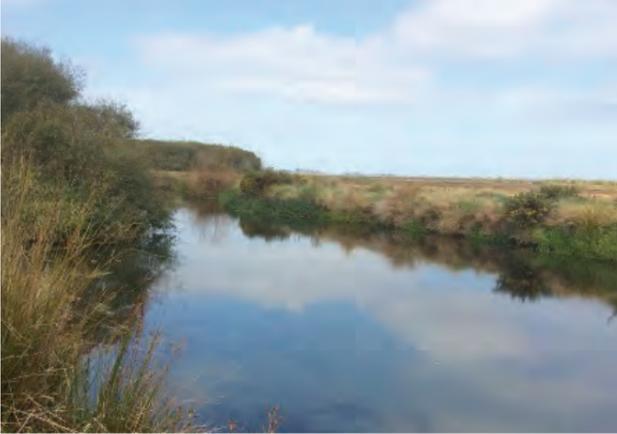
<p>Current state:</p> <ul style="list-style-type: none"> Run habitat. Average water depth approx. 1.0 m, with a wetted width ranging from 11 – 15 m. Soft-bottomed. Bank vegetation comprised of a mix of native and exotic vegetation, with willow trees, sedges and rushes providing overhead cover near bank margins. Channel shading low in reaches 1 and 2 (5 – 10 %), but higher in reaches 3 and 4 (20 – 25 %). Riparian cover high, especially along true left bank (TLB). Generally moderate to steep-angled stable banks that are unfenced. No active erosion / slumping observed. High cover of submerged macrophytes (45 – 75 %) – dominated by Elodea, Potamogeton and charophytes. <p>Potential enhancement options:</p> <ul style="list-style-type: none"> Tall riparian vegetation on TRB for channel shading and biodiversity value.

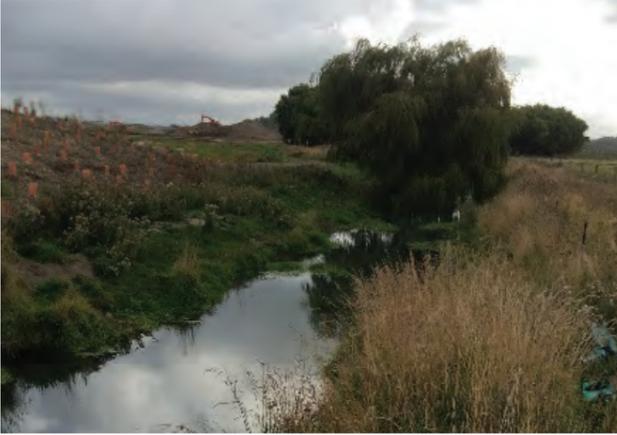
<p>Current state:</p> <ul style="list-style-type: none"> Run habitat. Water depth increases downstream, (0.3 m to 1.2m). Wetted width increases downstream (2 m to 6 m). Soft-bottomed, except reach 6 with larger gravel / pebble substrate (this reach modified, Liffey Springs development). Bank vegetation dominated by exotic grasses / herbs in lower reaches, and exotic trees in mid to upper reaches. Banks recontoured and recently planted in reach 6. Riparian cover high in reaches 3, 4 and 6, low elsewhere. Channel shading high in reaches 3 and 4, low elsewhere. Banks angles generally moderate to steep, and generally unfenced. Seven areas of active erosion / slumping observed. Macrophyte cover generally high throughout. Two springs observed in reaches 5 and 6. <p>Potential enhancement options:</p> <ul style="list-style-type: none"> Bank recontouring and riparian planting to stabilise banks, enhance biodiversity and provide stream shade.

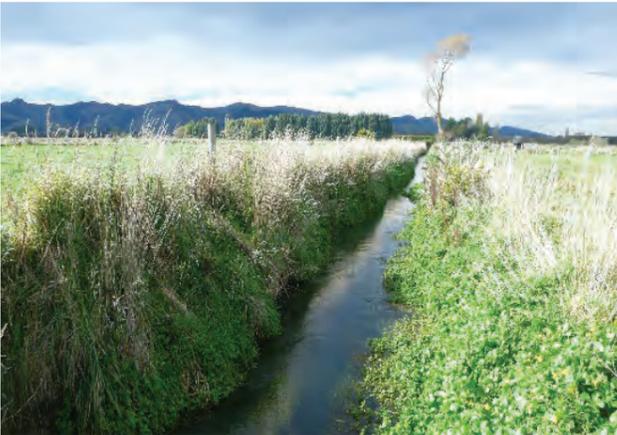
<p>Current state:</p> <ul style="list-style-type: none"> Straightened channel dominated by run habitat. Average water depth 0.4 – 0.7 m. Average wetted width 2.0 – 3.0 m. Soft-bottomed, except for localised patch of larger substrate at man-made weir near irrigation in-take structure at reach 3. Bank vegetation mainly exotic grasses with occasional exotic shrub / tree, reach 4 had greater cover of exotic trees. Banks steep (except reach 4) – and fenced throughout all reaches. Three areas of active erosion / slumping observed. Channel shading low (≤15 %); highest in uppermost reach. High macrophyte cover (35 – 90 %), comprised of a mixture of emergent and submerged forms. Numerous springs observed in reaches 3 and 4. <p>Potential enhancement options:</p> <ul style="list-style-type: none"> Bank recontouring and riparian planting to stabilise banks and provide shading; addition of boulders or snags to increase hydraulic variation.

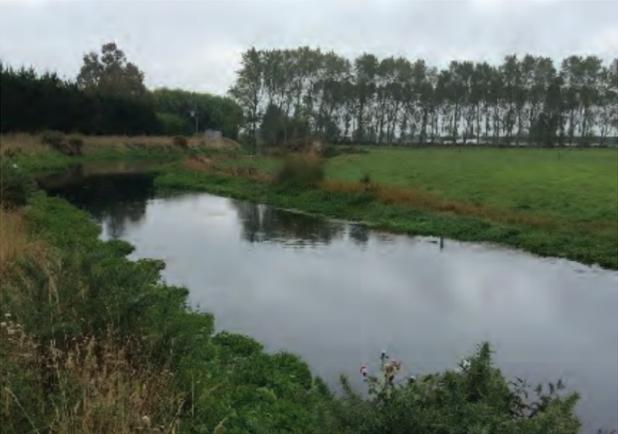
<p>Current state:</p> <ul style="list-style-type: none"> Run habitat. Average water depth generally >1.0 m, with average wetted widths ranging from 13 – 15 m. Predominantly soft-bottomed, with small patch of gravel substrate near road bridge. Bank vegetation dominated by rank grasses; very little tall woody riparian vegetation. Channel shading very low downstream of Yarrs Lagoon. Swamp nettle observed on true right bank (TRB) within the downstream edge of Yarrs Lagoon. Low to steep-angled stable banks that are fenced. One erosion / slumping hotspot observed. High cover of submerged macrophytes (80 – 90 %) – dominated by Elodea, Potamogeton and Myriophyllum. <p>Potential enhancement options:</p> <ul style="list-style-type: none"> Riparian planting for channel shading, habitat, and biodiversity value. biodiversity value, and bank stabilisation.

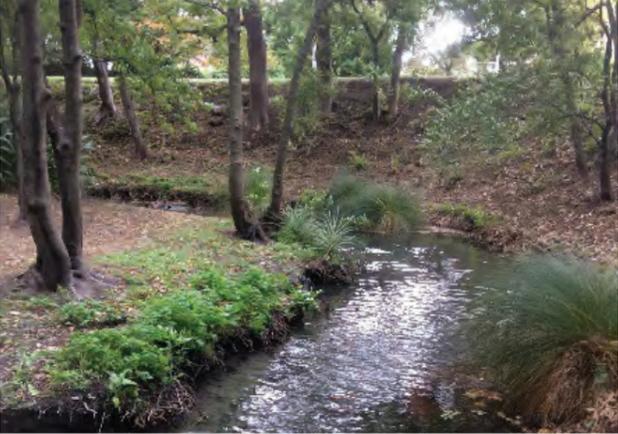
<p>Current state:</p> <p>Predominantly run habitat although riffle areas present in reach 8. Water depth generally shallow (average 0.1–0.5 m), with an average wetted width ranging from 2 – 6 m.</p> <ul style="list-style-type: none"> Soft-bottomed, except for reaches 5, 7, 8, 10 and 11 where gravel / pebble substrate was present. These areas of larger substrate were heavily embedded with fine sediment. Bank vegetation generally dominated by exotic trees, mixed understorey vegetation and exotic (or no) groundcover. Riparian cover and channel shading generally high. Banks angles vary considerably between reaches. Four areas of active erosion / slumping observed. Submerged macrophyte cover generally low throughout; emergent macrophyte cover high in reaches 2, 4 and 5. Numerous springs observed in reaches 4 and 6. <p>Potential enhancement options:</p> <ul style="list-style-type: none"> Sediment removal from riffle areas, and riparian planting to stabilise banks (and enhance biodiversity) where needed.

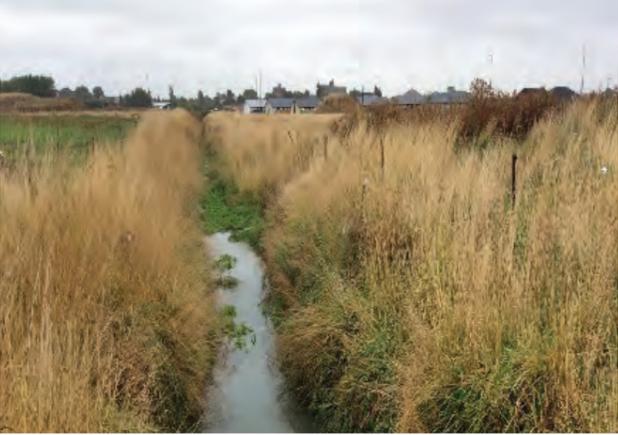
<p>Current state:</p> <ul style="list-style-type: none"> Straightened channel dominated by run habitat. Average water depth ranged from 0.5 – 1.0 m. Average wetted width varied from 1.6 – 2.3 m. Soft-bottomed, except for localised patch of larger substrate at confluence of channel from Te Whiriki development. Bank vegetation dominated by exotic grasses; no woody riparian vegetation present. Channel shading very low. Banks are steep, which are fenced throughout. Multiple areas of active erosion / slumping observed. Numerous large eels and inanga observed. High macrophyte cover (65 – 80 %), comprised of a mixture of emergent and submerged forms – dominant species include Erythranthe, Nasturtium and Elodea. <p>Potential enhancement options:</p> <ul style="list-style-type: none"> Bank recontouring and riparian planting to stabilise banks and provide shading; addition of boulders or snags to increase hydraulic variation.

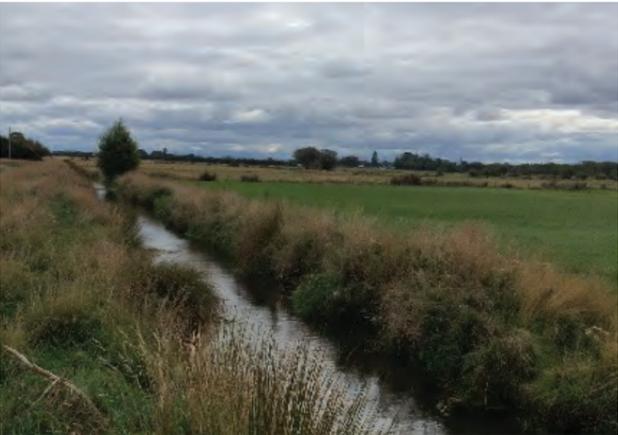
<p>Current state:</p> <ul style="list-style-type: none"> Straightened channel dominated by run habitat. Average water depth 0.2 – 0.7 m. Average wetted width 0.6 – 3.0 m. Upper reaches ephemeral (i.e., from reach 4 upstream). Soft-bottomed, except for small patch of gravel in reach 3. Variable bank vegetation, dominated by exotic grasses, with occasional exotic shrubs / trees. Reach 2 had higher cover. Riparian cover and shading highest on TLB in reaches 2 and 4. Riparian cover and shading low in remaining reaches. Banks angles generally steep to vertical, and fenced through farmland. Two areas of active erosion / slumping observed. High macrophyte cover (50–75 %) in reaches 1 and 3, low in remaining reaches (≤5 %). Numerous springs observed in reach 1. <p>Potential enhancement options:</p> <ul style="list-style-type: none"> Bank recontouring and riparian planting to stabilise banks and provide shading; addition of boulders or snags to increase hydraulic variation.

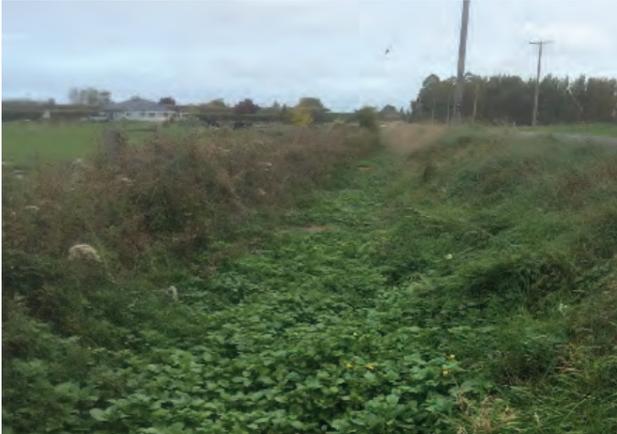
<p>Current state:</p> <ul style="list-style-type: none"> ■ Straightened channel dominated by run habitat. Average water depth 0.4 – 1.5 m. Average wetted width 1.5 – 2.7 m. ■ Soft-bottomed. ■ Variable bank vegetation. Mainly native sedges, rank grasses and exotic shrubs / trees. Native riparian planting on TLB at reach 9. ■ Banks mainly moderate to steep and partially fenced through farmland. Two areas of active erosion / slumping observed. ■ Channel shading generally low, except for reach 5 (85 %). ■ Riparian cover generally highest in lower reaches, and along TRB of reaches 5 and 6 and TLB of reach 9. ■ High macrophyte cover throughout, except reach 5 (15 %). ■ High filamentous algal cover in reaches 6 and 7 (40 – 70 %). ■ Spring observed between reaches 3 and 4. <p>Potential enhancement options:</p> <ul style="list-style-type: none"> ■ Riparian planting to stabilise banks and provide shading; addition of boulders or snags to increase hydraulic variation. 	Days (tributary)

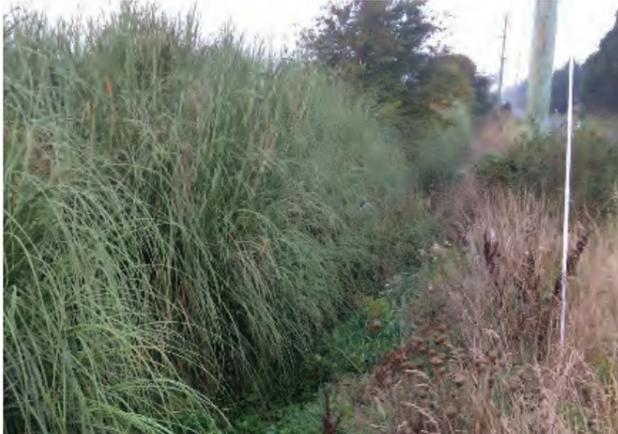
<p>Current state:</p> <ul style="list-style-type: none"> ■ Straightened channel dominated by run habitat. Average water depth 0.1 – 0.3 m. Average wetted width 1.0 – 1.5 m. ■ Soft-bottomed. ■ Bank vegetation dominated by exotic grasses and exotic shrubs / trees, except native riparian planting at reach 3. ■ Banks moderate to steep and fenced along TLB (through farmland). No active erosion / slumping observed. ■ Channel shading moderate to high, except reach 3 (15%). ■ Riparian cover highest on TLB (70 – 95 %), and low on TRB except for reach 2. ■ High filamentous algal cover in reaches 1 and 5 (30 – 40 %). ■ High macrophyte cover, except reaches 2 and 5 (5 – 15 %). <p>Potential enhancement options:</p> <ul style="list-style-type: none"> ■ Riparian planting to provide shading; addition of boulders or snags to increase hydraulic variation.

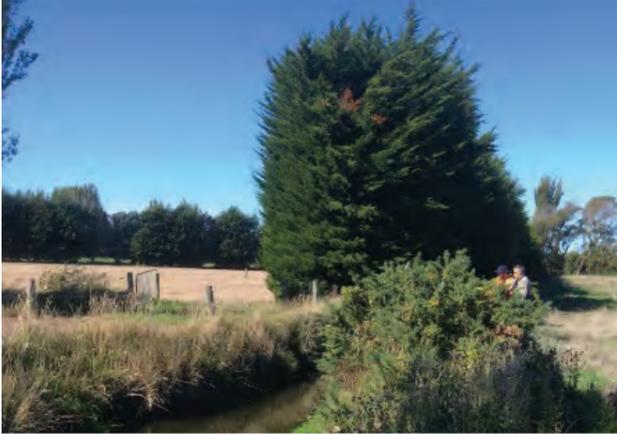
<p>Current state:</p> <ul style="list-style-type: none"> ■ Straightened channel dominated by run habitat. Average water depth 0.5 – 0.6 m. Average wetted width 2.4 – 4.2 m. ■ Soft-bottomed. ■ Bank vegetation generally dominated by exotic grasses (and occasional exotic shrub) on TLB and exotic trees on TRB. ■ Banks moderate to steep and unfenced. Erosion / slumping and stock damage observed along TLB of reach 1. ■ Channel shading moderate to high: 60 – 80 % in reaches 1 and 2; and 25 – 30 % in reaches 3 and 4. ■ Riparian cover high on TRB and low on TLB throughout. ■ Macrophyte cover relatively low throughout (<20 %). <p>Potential enhancement options:</p> <ul style="list-style-type: none"> ■ Fencing to prevent stock access to waterway, and riparian planting to stabilise banks; addition of boulders or snags to increase hydraulic variation. 	Goodericks (tributary)

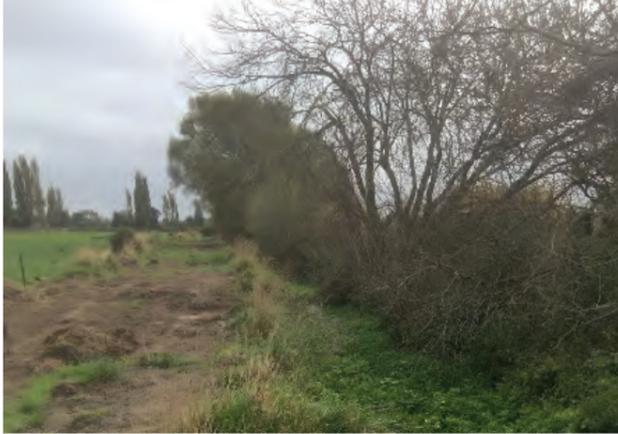
<p>Current state:</p> <ul style="list-style-type: none"> ■ Straightened channel dominated by run habitat. Average water depth 0.3 – 1.0 m. Average wetted width 1.4 – 5.0 m. ■ Soft-bottomed reaches 1-3, hard-bottomed reaches 4-7. Gravel/pebble substrate not heavily embedded with fines. ■ Bank vegetation in reaches 1-2 mainly exotic grasses, herbs and shrubs on TRB and exotic trees on TLB. Other reaches mainly exotic grasses on TRB, exotic shrubs / tree on TLB. ■ Banks low to steep and mainly fenced through farmland. No active erosion / slumping observed. ■ Channel shading low, apart from reach 3 (35 % shaded). ■ Riparian cover high on TLB of reaches 1 – 5, otherwise low. ■ High filamentous algal cover in reaches 1 and 6 (35 – 60 %). ■ Macrophyte cover very high throughout all reaches (>80 %). Emergent forms generally dominant. ■ Numerous springs observed in reaches 3 and 6. <p>Potential enhancement options:</p> <ul style="list-style-type: none"> ■ Bank recontouring and riparian planting to provide shade and expose hard-bottomed substrates in upper reaches; addition of boulders or snags to increase hydraulic variation.

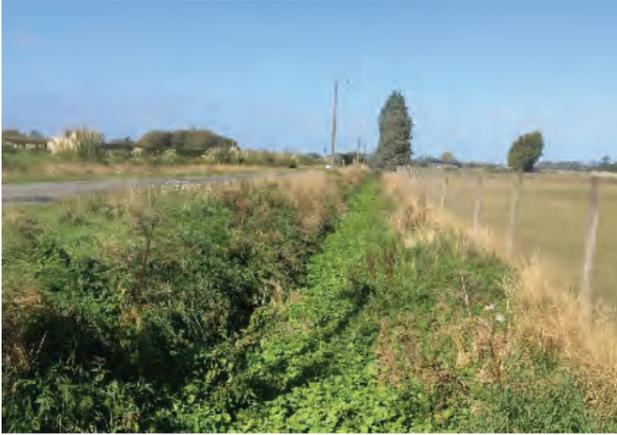
<p>Current state:</p> <ul style="list-style-type: none"> ■ Straightened channel dominated by run habitat. Average water depth 0.2 – 0.9 m. Average wetted width 1.5 – 4.0 m. ■ Soft-bottomed reaches 1-3, hard-bottomed reaches 4-11. Gravel/pebble substrate not heavily embedded with fines. ■ Variable bank vegetation, mainly exotic grasses, shrubs and trees. Native riparian planting was present on the TRB downstream of the intersection of Days and Powells roads. ■ Banks low to steep and fenced through farmland. Three areas of active erosion / slumping observed. ■ Channel shading low in most reaches, apart from reach 2, 5 and 11 which were moderately shaded (25 – 30 %). ■ Riparian cover variable between reaches. ■ Macrophyte cover very high throughout (>80%). Submerged forms dominant lower three reaches, while emergent forms dominant upstream. ■ High filamentous algal cover in reaches 1 and 3 (70 – 75 %). ■ Numerous springs observed in reaches 2, 3 and 6. <p>Potential enhancement options:</p> <ul style="list-style-type: none"> ■ Bank recontouring and riparian planting to provide shade, expose hard-bottomed substrates in mid to upper reaches, addition of boulders or snags to increase hydraulic variation.

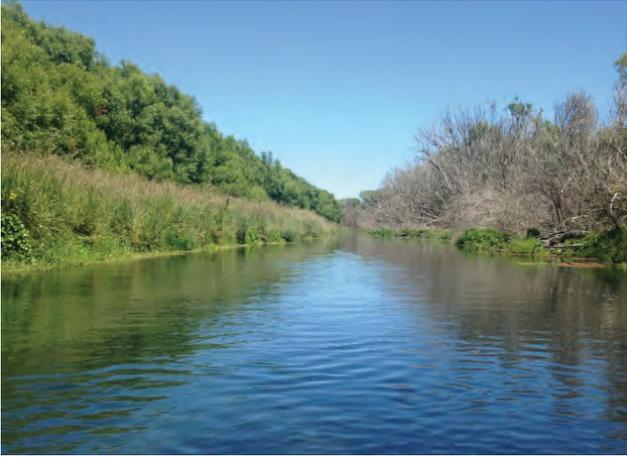
A bird's eye view of Yarrs Lagoon. This area contains significant wetland vegetation and should be a focal point for restoration efforts in the catchment.

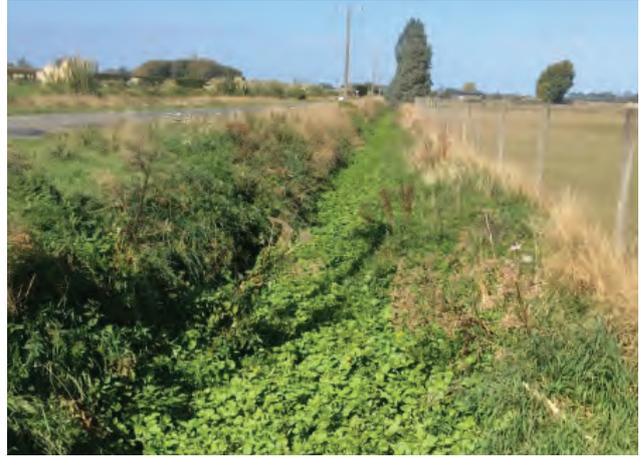
Tributary waterways such as these would greatly benefit from riparian shading to reduce macrophyte growth.

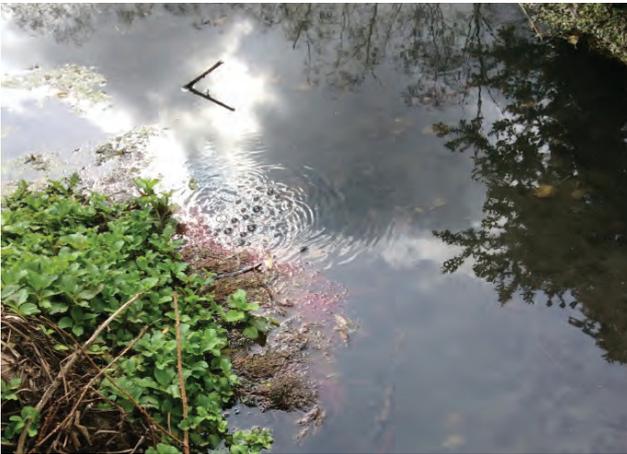
Photograph from Liffey Stream showing a spring source in the centre of the channel (bubbling up). Springs should be protected across the catchment.

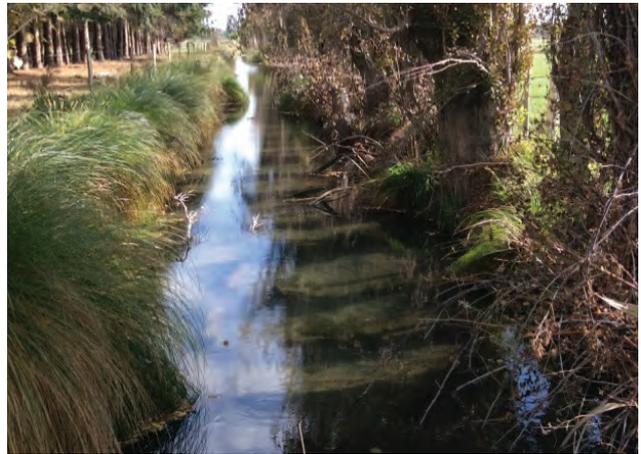
The benefits of shading provided by riparian vegetation: reduced macrophyte growth and reduced channel maintenance requirements.

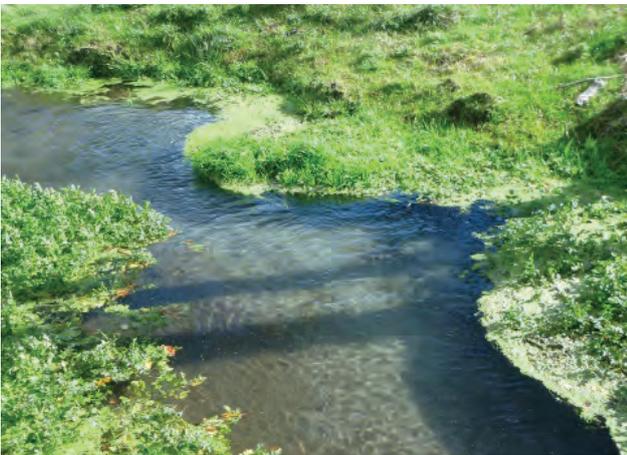
Inputs of sediment can lead to very high sediment cover on the streambed, which reduces habitat quality for aquatic invertebrates and fish. This can have subsequent detrimental effects on terrestrial animals that live in or near the riparian margin (e.g., birds feed on the adult stages of aquatic insects).
