ARARIRA / LII CATCHMENT: HYDROLOGY, ECOLOGY AND WATER QUALITY

Report Number: 1414458_7410-003-R-Rev2

NOVEMBER 2015

The scope of this report is to describe the hydrology, water quality and ecology of the Ararira / LII River catchment, to identify environmental enhancement opportunities, and to provide monitoring recommendations.

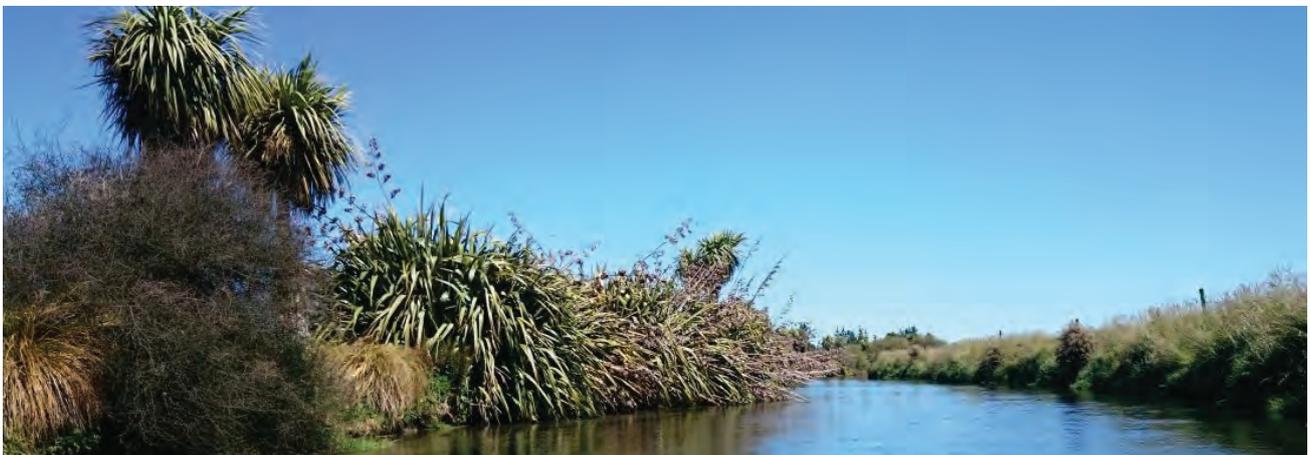
Photograph from the mainstem downstream of Pannetts Rd Bridge showing well-established riparian plantings on the true left bank. Such plantings improve bank stability, provide refuge, foraging and nesting habitat for a diverse range of terrestrial animals, and also provide overhanging cover for aquatic animals that is largely absent from riparian margins in the catchment.

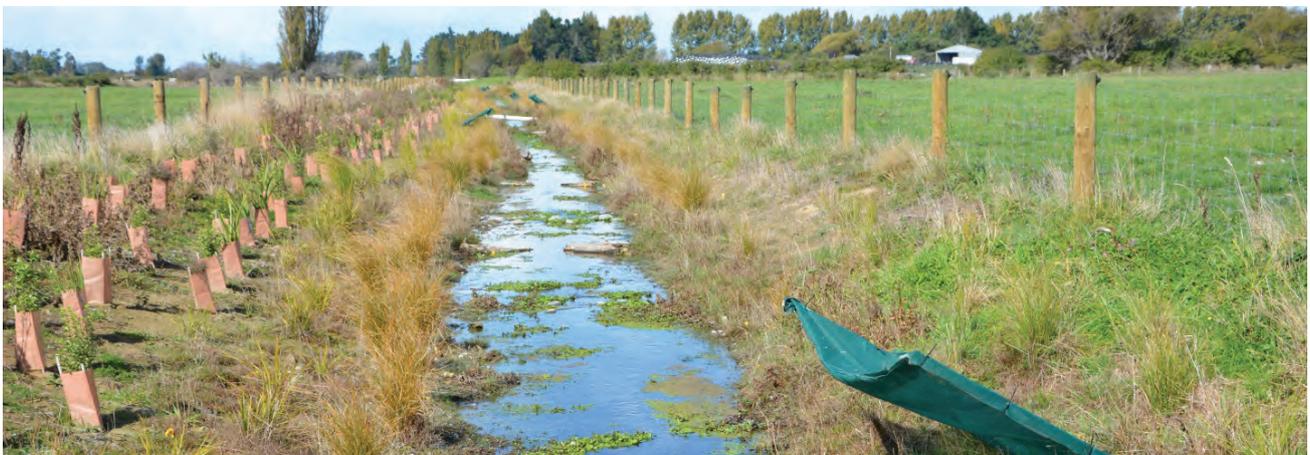
An example of a restored ditch in the Silverstream catchment a similar spring-fed tributary of Te Waihora / Lake Ellesmere. The riparian plantings were undertaken 12 months prior to the taking of this photograph.
