REPORT NO. 3671

**WAITUNA CREEK INSTREAM RESTORATION
TRIAL ASSESSMENT: THE EFFECT OF INSTREAM
HABITAT STRUCTURES ON THE FISH COMMUNITY**

ROBIN HOLMES, ERIC GOODWIN

Department of Conservation Southland

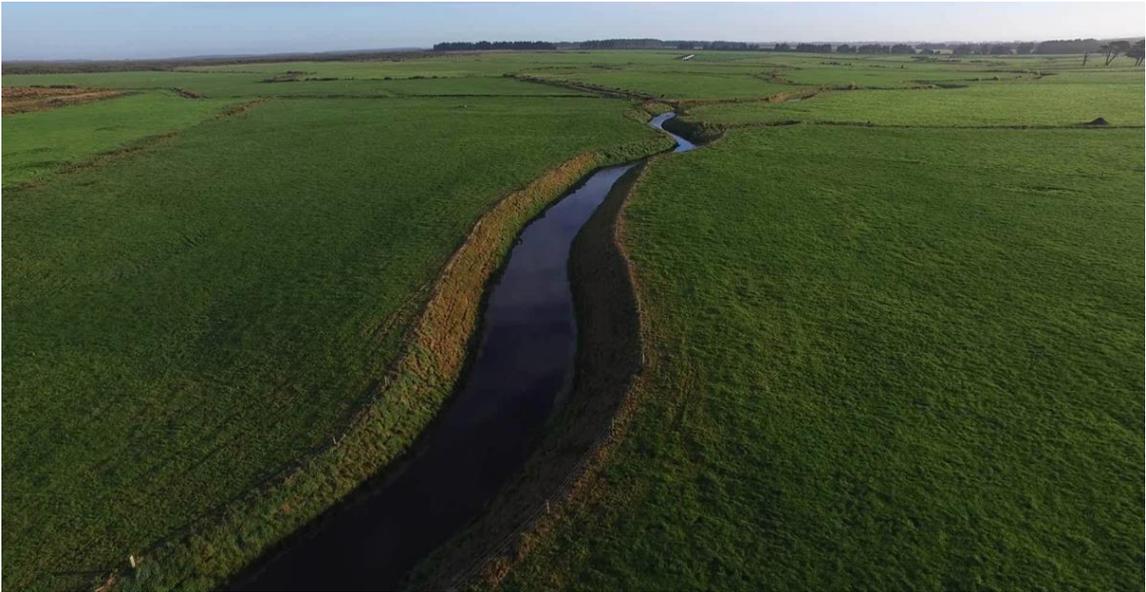
Figure 1. An aerial perspective of the lower Waituna Creek (taken prior to the rehabilitation trial) showing similar and continuous 'slow-run' type habitat for about a kilometre (Holmes 2019a). Photo credit: Bruce Green.

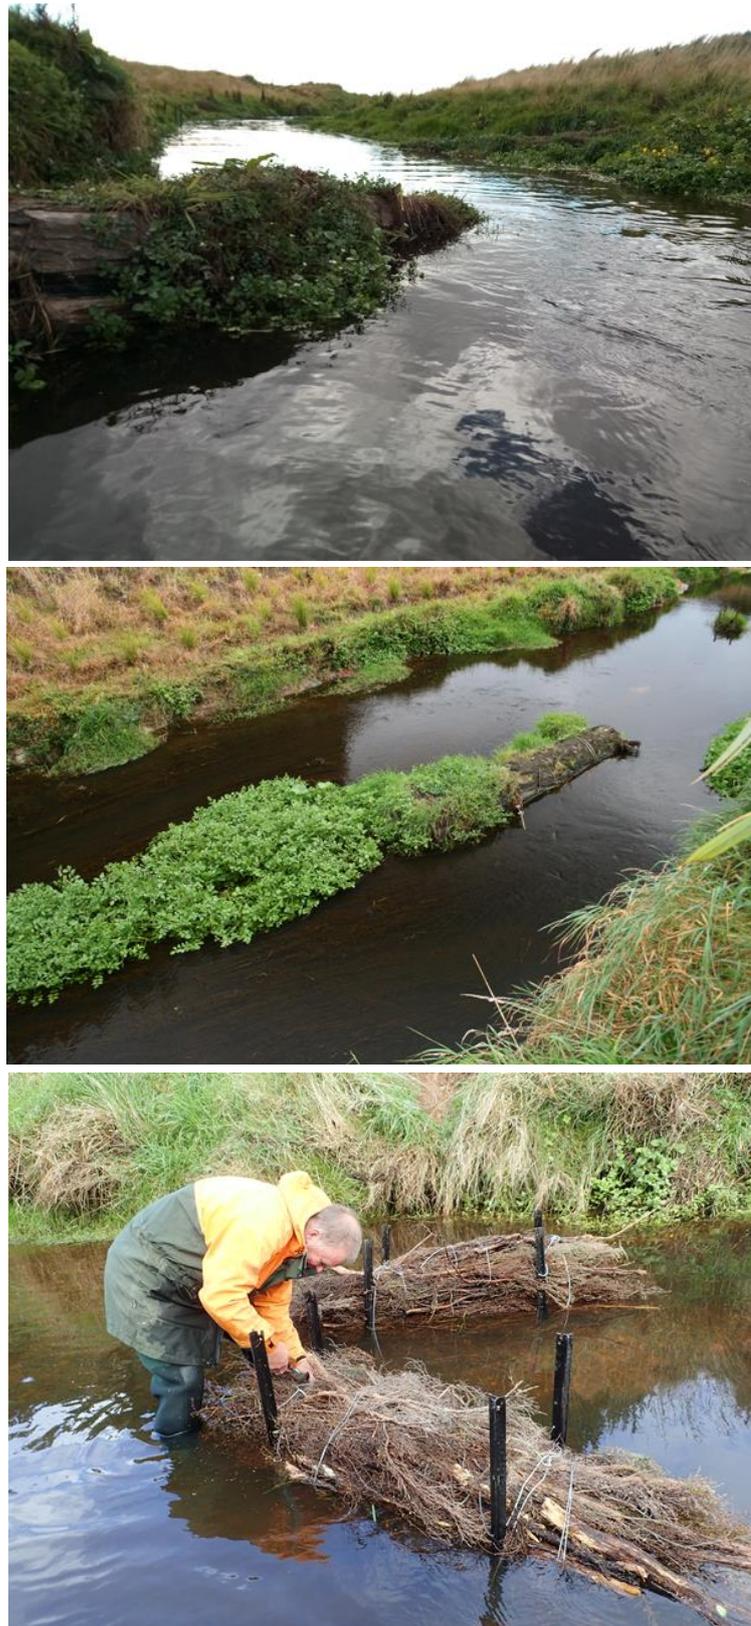
Figure 3. Waituna Creek showing examples of the logs (top and middle) and manuka bundles (bottom) installed within the rehabilitation trial reaches to improve fish habitat (figures reproduced from Holmes 2019a).

To increase instream habitat diversity, large logs (approximately 4 m long and 0.5 m in diameter) and tightly packed bundles of manuka sticks were installed directly onto the stream bed. A condition of the restoration trial consent was that the structures were 'removable'. Accordingly, steel pipes and warratahs were used to fix the logs and manuka bundles in place, respectively (Figure 3).

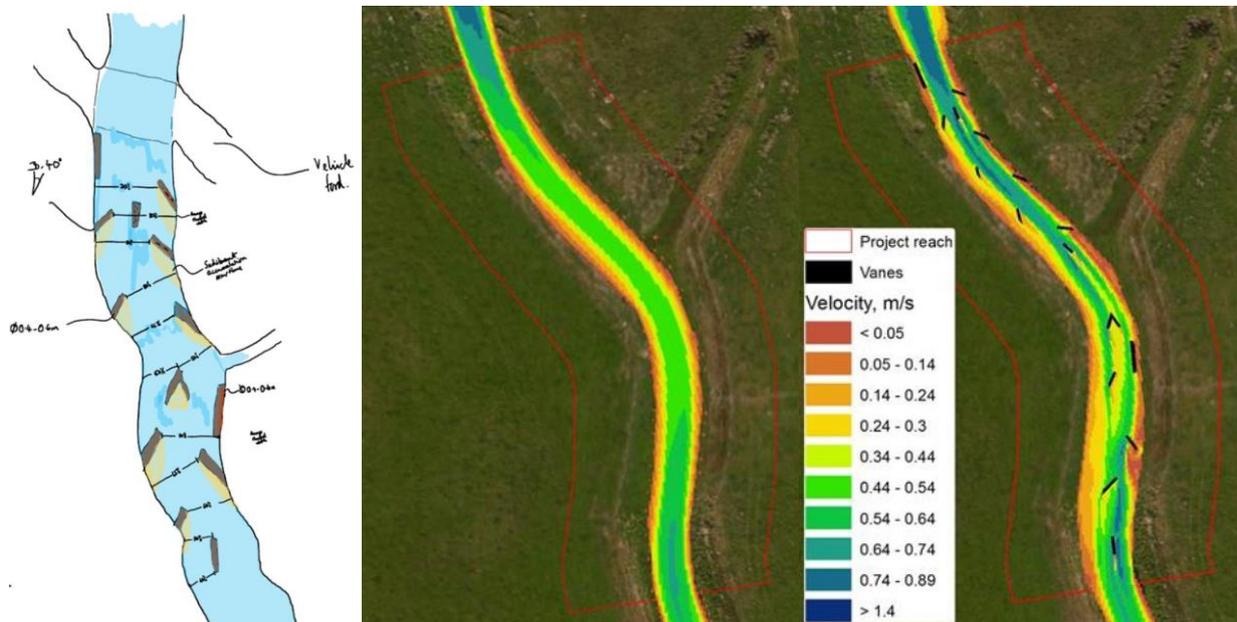
Figure 4. Conceptual sketch of log placement (left) and hydraulic modelling of the restoration reach without logs (middle) and with logs (right). Colours show water velocity gradient from slow (red) to fast (blue) figure reproduced from Walsh et al. (2017).

Before a final arrangement of structures was chosen, the potential effects of different log configurations on velocity variation, upstream impoundment and bank erosion were modelled by the National Institute of Water and Atmospheric Research (NIWA) (Figure 4) (Walsh et al. 2017).

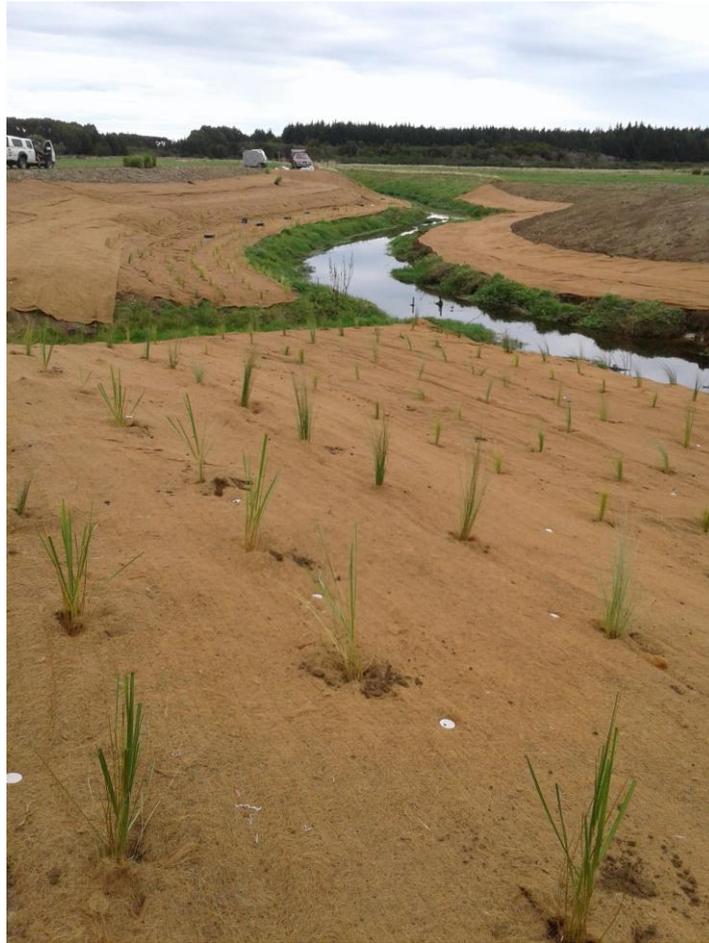
Figure 5. The Site 2 rehabilitation reach showing recent plantings and two-stage channel design, photograph taken in 2018 from bank-full looking downstream.

In conjunction with creating a two-stage channel and installing woody habitat structures, native riparian planting and weed control is ongoing in the segment of creek containing the rehabilitation reaches. Planting below the bank-full channel was limited to low-stature grasses such as *Carex secta* (Figure 5). This was a requirement of the project trial consent conditions to ensure the flood capacity of the channel is maintained. Some larger-stature shrubs and trees have been planted on the upper bank above the bank-full channel.

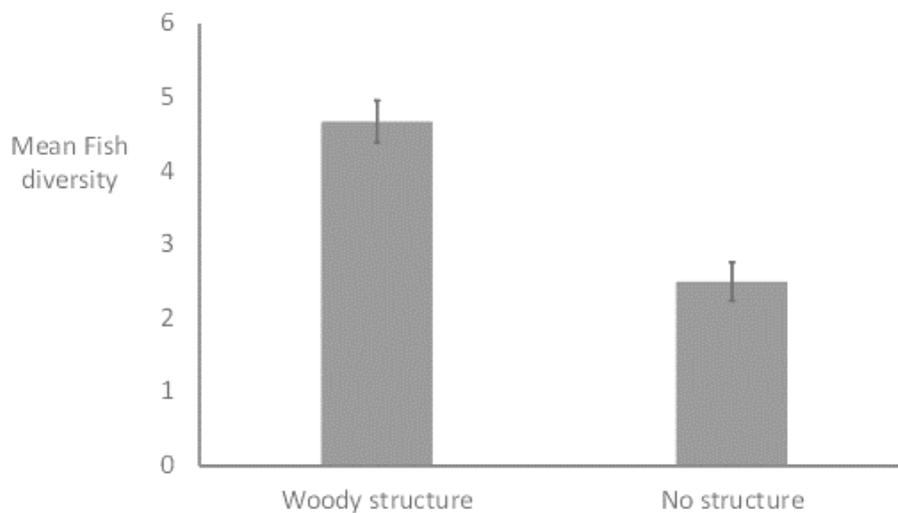
Figure 6. Average values for mean fish diversity determined from electric fishing in the 12 stream patches containing installed woody structures and 12 paired 'no structure' streambed patches. Error bars represent standard error of the mean.

The woody structure patches had higher average fish diversity (Figure 6), biomass (Figure 7) and abundance (Figure 8) when compared to the no-structure patches. Comparison of means shows that all these differences were statistically significant (Table 2).

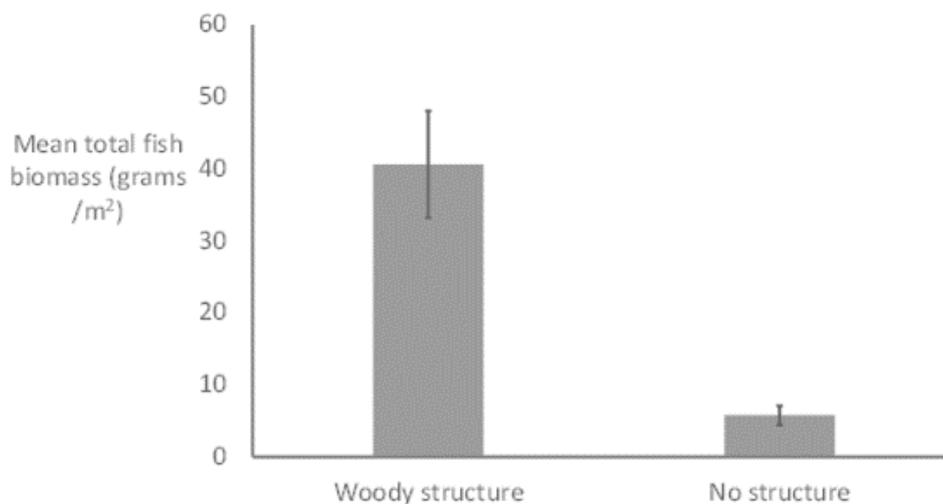
Figure 7. Average values for mean total fish biomass (grams/m²) determined from electric fishing in the 12 stream patches containing installed woody structures and 12 paired 'no structure' streambed patches. Error bars are standard errors.

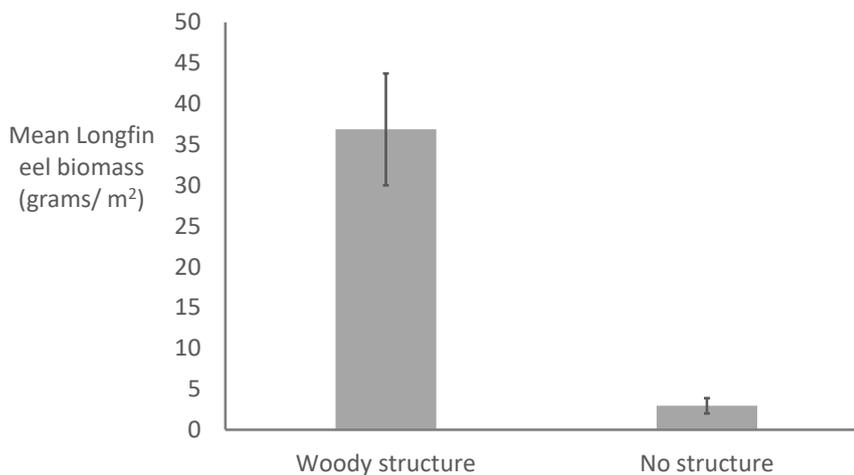
Figure 9. Average values for mean longfin eel biomass (grams/m²) determined from electric fishing in the 12 stream patches containing installed woody structures and 12 paired 'no structure' streambed patches. Error bars are standard errors.

Overall, longfin eel biomass was around ten times higher in the patches of stream around the installed woody structures—when compared with the no-structure patches (Figure 9). Fish biomass with eels subtracted (i.e. total biomass of all fish except for eels) was around a 40% higher in the structure patches; however, this difference was not statistically significant (Figure 10).

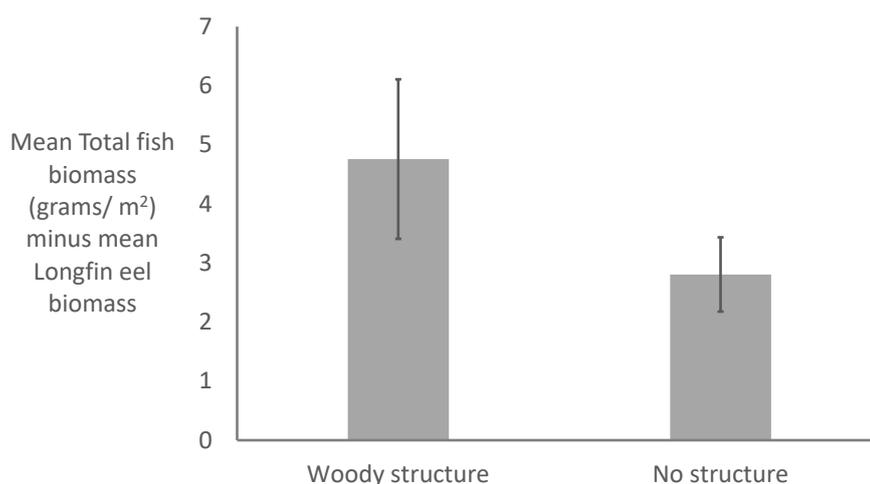
Figure 10. Average values for mean biomass (grams/m²) of all fish except for eels, determined from electric fishing in the 12 stream patches containing installed woody structures and 12 paired 'no structure' stream bed patches. Error bars are standard errors.

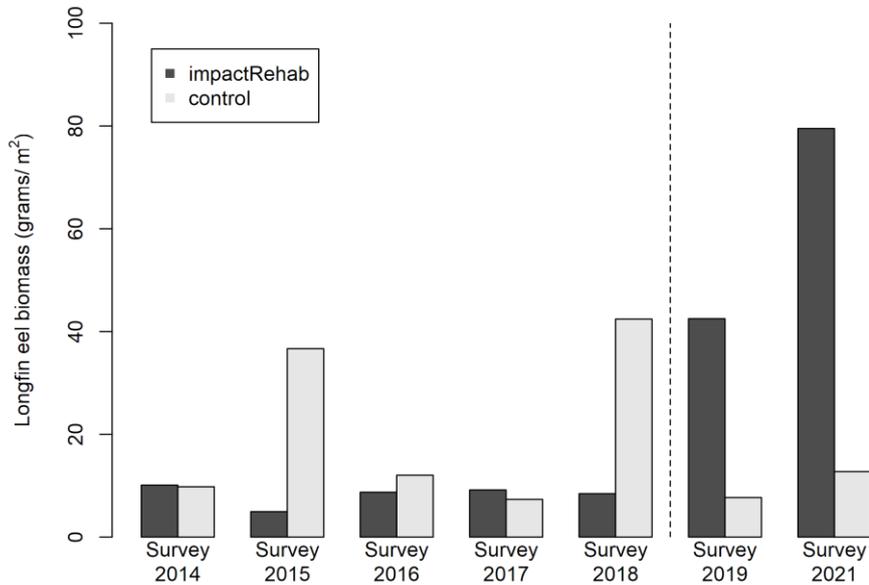
Figure 11. Longfin eel biomass (grams/m²) at Site 2 and the upstream control sites (average of sites 4 and 5) for all monitoring years. Dotted line shows the point in time when rehabilitation works were completed.

In contrast to the lack of response at Site 0, we found a positive impact of the rehabilitation measures on all three of our key success indicators at Site 2. There was a significant increase in longfin eel biomass—driven by the occurrence of a few relatively large eels occurring in the reach (Table 3, Figure 11). This is shown by the significant increase in the upper quartile weight of longfin eels after the rehabilitation treatment (Figure 12). Giant kōkopu biomass increased significantly at Site 2 (from a baseline of zero during all years prior to rehabilitation) (Figure 13). For both eels and giant kōkopu there were no substantial changes in biomass at the control sites in the years after the rehabilitation. This indicates an effect of the rehabilitation treatment,

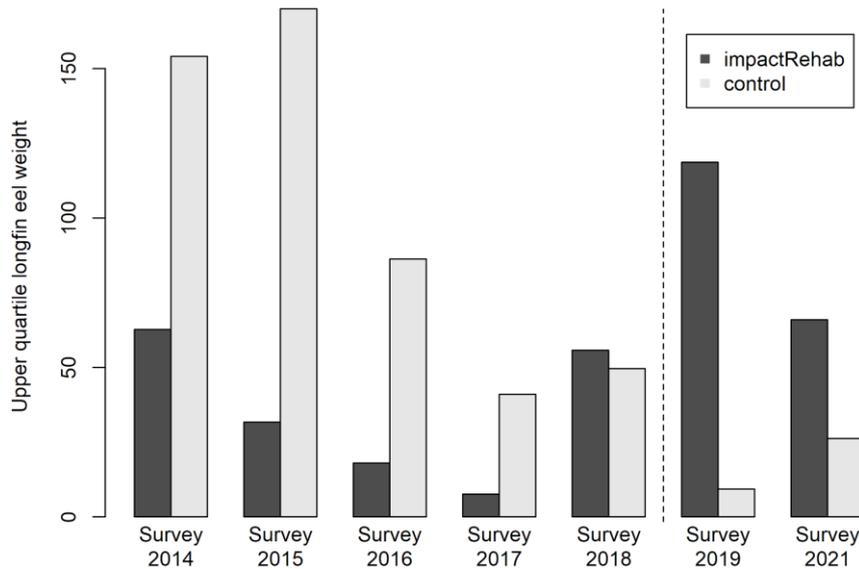
Figure 12. Longfin upper quartile weight (in grams) at Site 2 and the upstream control sites (average of sites 4 and 5) for all monitoring years. Dotted line shows the point in time when rehabilitation works were completed.

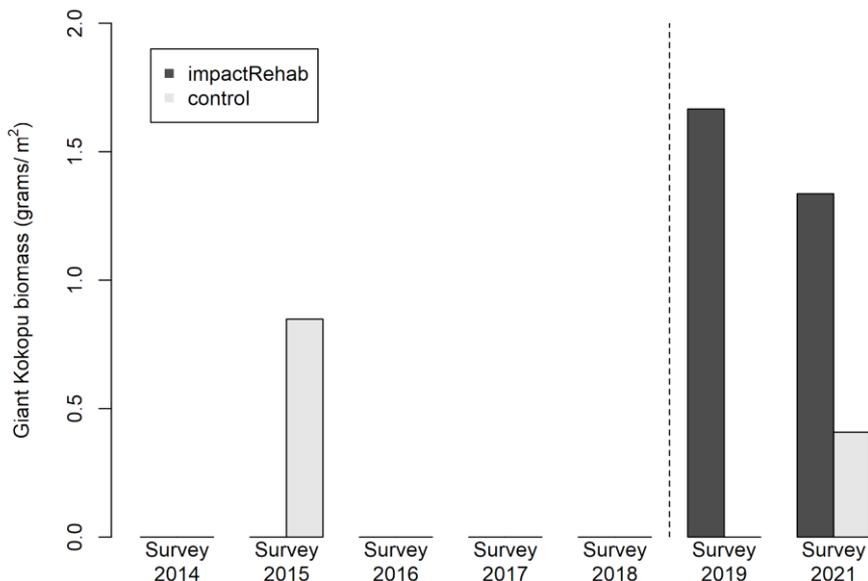
Figure 13. Giant kokopu biomass (grams/m²) at Site 2 and the upstream control sites (average of sites 4 and 5) for all monitoring years. Dotted line shows the point in time when rehabilitation works were completed.

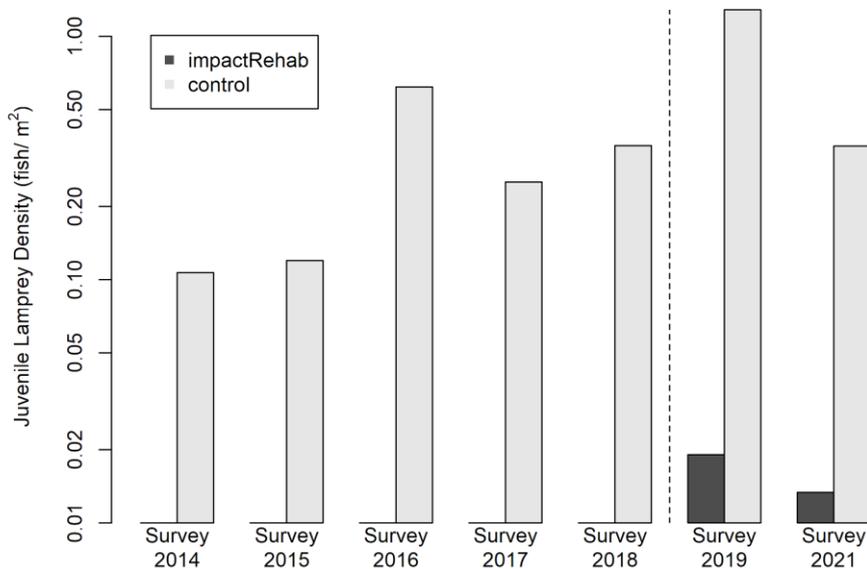
Figure 14. Juvenile lamprey density (fish / m²) results at Site 2 and the upstream control sites (average of sites 4 and 5) for all monitoring years. Dotted line shows the point in time when rehabilitation works were completed. Densities are plotted on a log scale to enable visualisation of low densities of lamprey detected at Site 2, after the rehabilitation treatment.

Low numbers of juvenile lamprey were found, for the first time, at Site 2 during both of the years following the rehabilitation. However, relatively large numbers of juvenile lamprey also occurred at the control site during these two years (Figure 14).

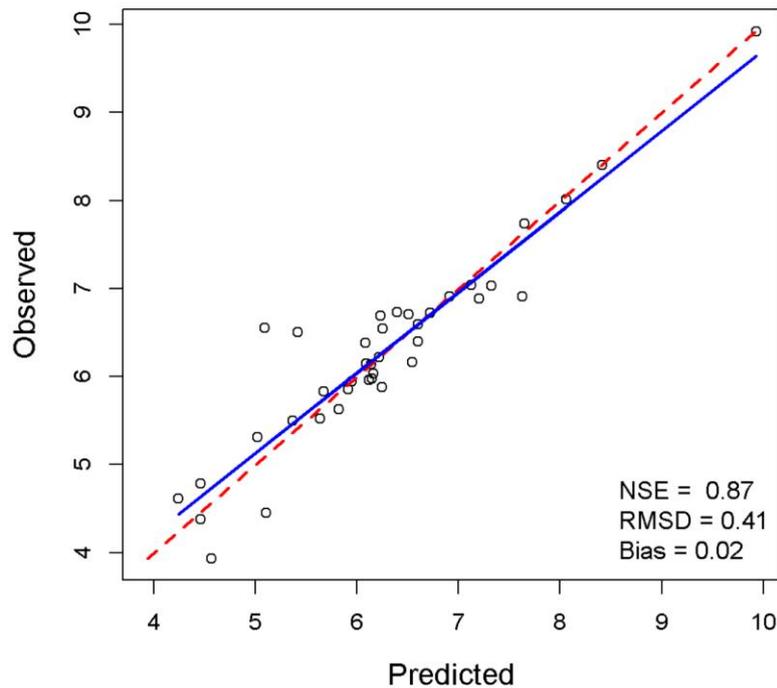
Figure 15. The relationship between total fish density predicted from first pass density data only (predicted) and the total fish population density estimate based depletion count curve fitting (observed). Blue line represents the model fit and the red line represents the 1:1 relationship. Model parameters Nash-Sutcliffe efficiency coefficient (NSE), root mean square deviation (RMSD) and model bias are displayed.

An exploratory analysis was undertaken on the entire Waituna fish population data set to determine if single pass data could be used as a surrogate for multi-pass data. In essence, this was done to determine if the electric fishing results undertaken to date (with multiple passes) could inform and reduce monitoring effort in the future (to single pass data collection). In general, across all sites and all years, the abundance of fish determined from the first pass was a good predictor of total abundance predicted from the multi-pass data (Figure 15).

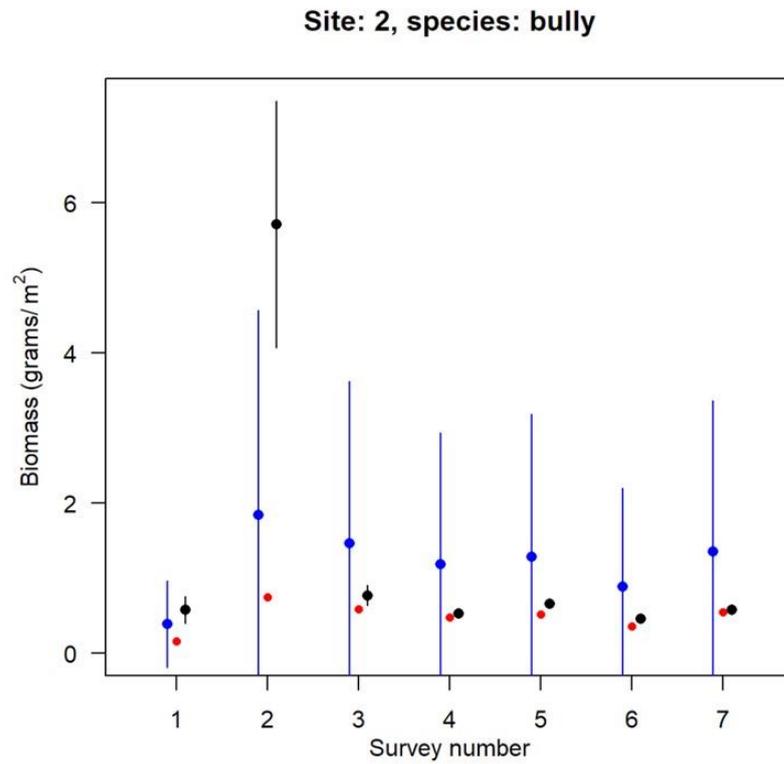
Figure 16. Total biomass estimates at Site 2 for all three species of bullies combined (common, redfin and giant bullies) calculated from single pass (blue dots) and the multi-pass depletion count method (black dots). The red dot shows the biomass from the first pass. Bars represent 95% confidence intervals for the population estimates.

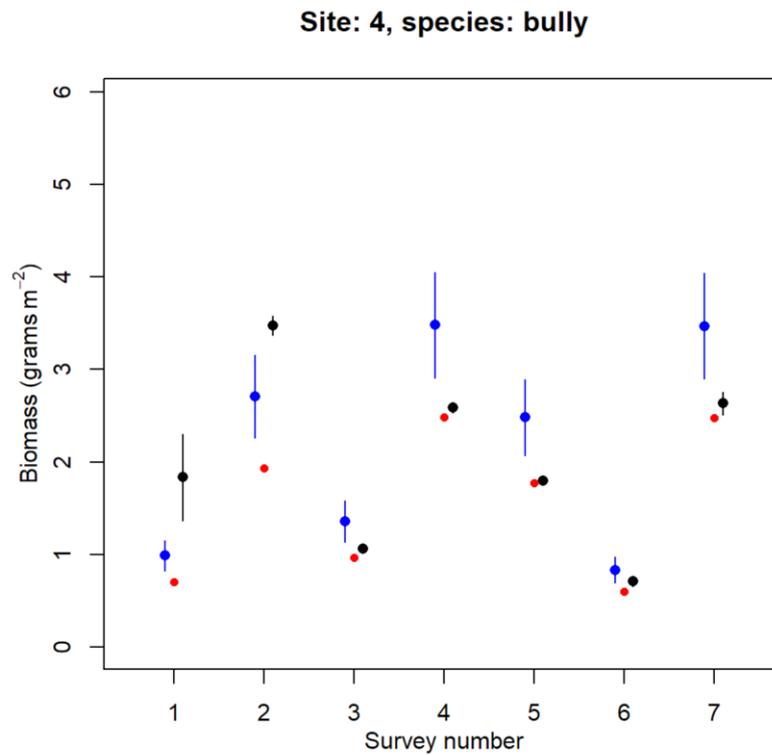
Figure 17. Total biomass estimates (fish/m²) at Site 4 for all three species of bullies (common, redfin and giant), calculated from single pass (blue dots) and the multi-pass depletion count method (black dots). The red dot shows the biomass from the first pass. Bars represent 95% confidence intervals for the population estimates.

However, both 'site' and 'time' were significant terms within the predictive model. This indicates that the reliability of using the single pass method will vary depending on the reach or the year. For example, at Site 2, the potential confidence intervals around bully biomass (all species combined) are very wide for the total population estimate based on the single pass data. If monitoring were based on single pass data at this site, a very large change in biomass would be needed before a difference in the population could be detected (e.g. an order of magnitude increase or decrease over many years) (Figure 16). In contrast, both methods of estimating the total population for bullies at Site 4 (single pass vs. depletion count) showed the same general pattern in biomass changes overtime. The estimated error increased under the single pass method, but not to the degree that would prevent detection of trends overtime (Figure 17).

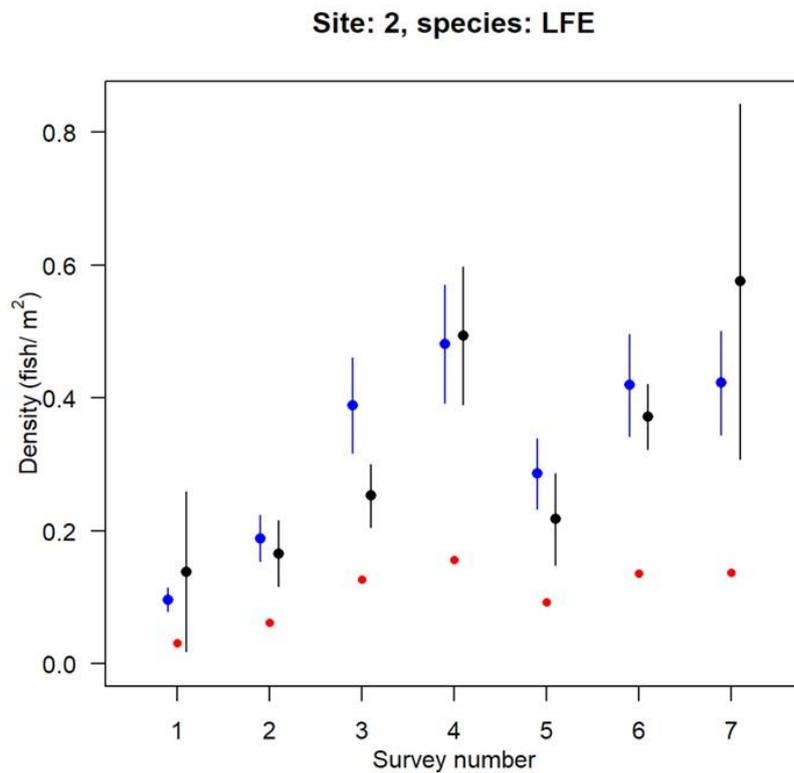
Figure 18. Total density estimates (fish/m²) at Site 2 for longfin eel, calculated from single pass (blue dots) and the multi-pass depletion count method (black dots). The red dot shows the biomass from the first pass. Bars represent 95% confidence intervals for the population estimates.

At most sites, longfin eel density estimates derived from our single pass vs. multiple pass total population estimates appeared to give a similar level of accuracy. For example, Figure 18 shows the comparison of total population estimate methods for longfin eel density at Site 2.

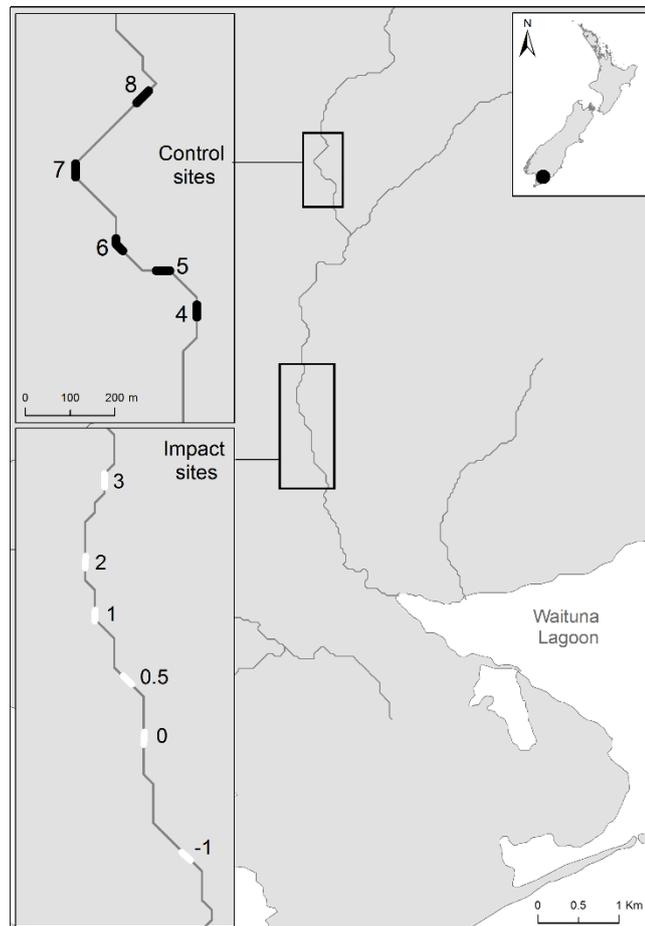
Appendix 2. All sites along the Waituna Creek sampled in association with the rehabilitation project since 2014.

Site	Site type	Easting	Northing
-1	Impact	2167686	5397904
0	Impact*	2167566	5398271
0.5	Impact	2167534	5398477
1	Impact	2167415	5398659
2	Impact*	2167363	5398816
3	Impact	2167412	5399096
4	Control	2167854	5401437
5	Control	2167780	5401531
6	Control	2167653	5401568
7	Control	2167597	5401750
8	Control	2167688	5401933
