Research report

# CAREX science contribution to Living Water in the LII/Ararira River from 2018–2020

Jon Harding & Chris Meijer

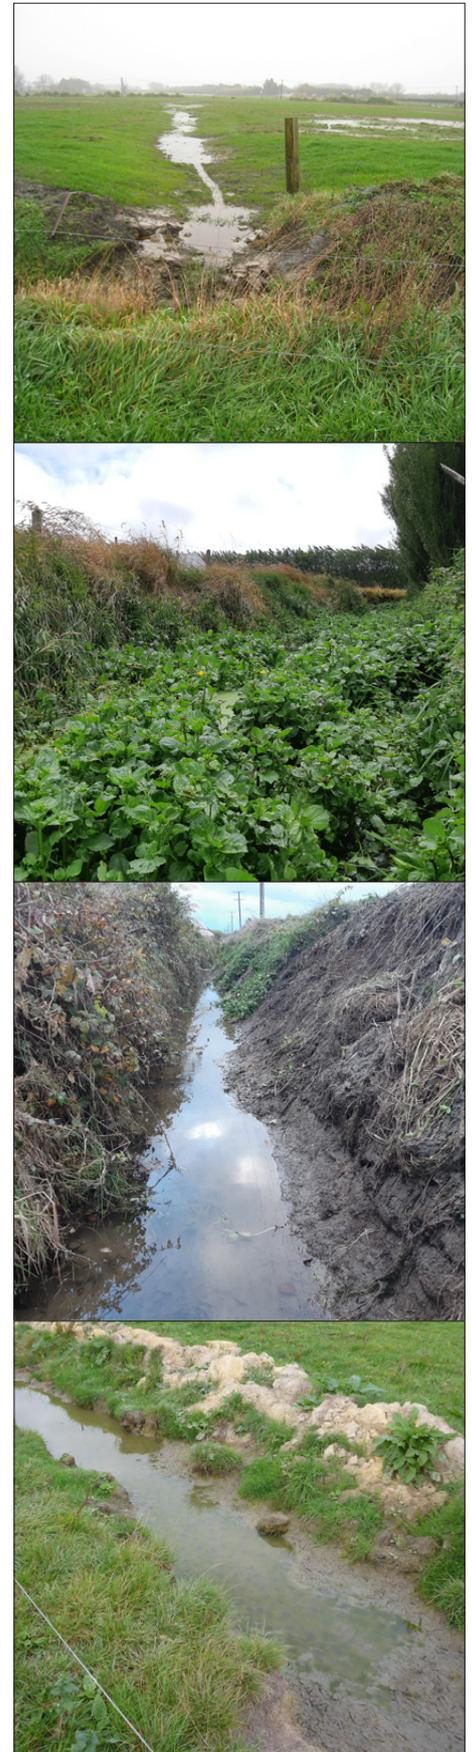
**Figure 2.** The issues raised in preliminary discussions were (A) flooding, (B) macrophytes, (C) drain cleaning, and (D) excessive fine sediment.

## The main issues identified by landowners were (Fig. 2);

- Flooding of farm fields. In the lower catchment closer to Lake Ellesmere/Te Waihora fields could be too wet to farm for much of the winter. In the upper catchment extreme storms could cause widespread flooding.
- Excessive aquatic weeds (macrophytes) particularly during spring and summer. These weeds grow annually and can completely clog on-farm waterways and roadside drains. These waterways are typically 1–3 m wide and the weeds are dominated by two introduced species; Monkey Musk (*Erythraete guttata*) and Watercress (*Nasturtium microphyllum*).

- Drain cleaning - annual “cleaning” occurs in many roadside drains to remove excessive invasive macrophytes and fine sediment. The sediment removal severely disrupts the bed, damaging habitat and removing freshwater invertebrates and fish. Material from the bed is also left on the banks causing very steep banks. This can result in bank slumping and creates sources of sediment addition into the waterways.

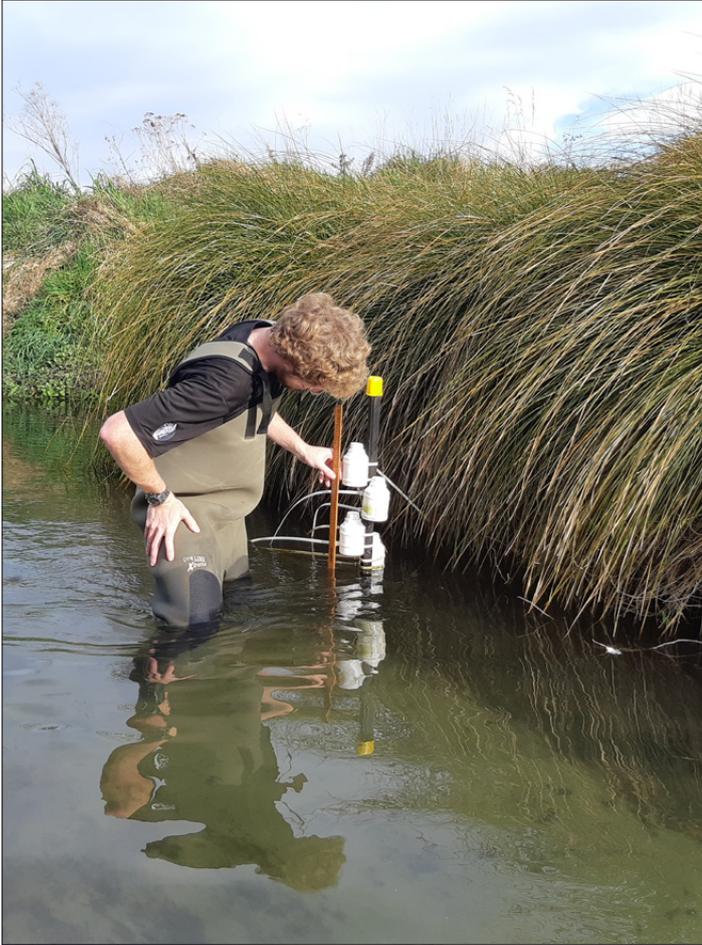
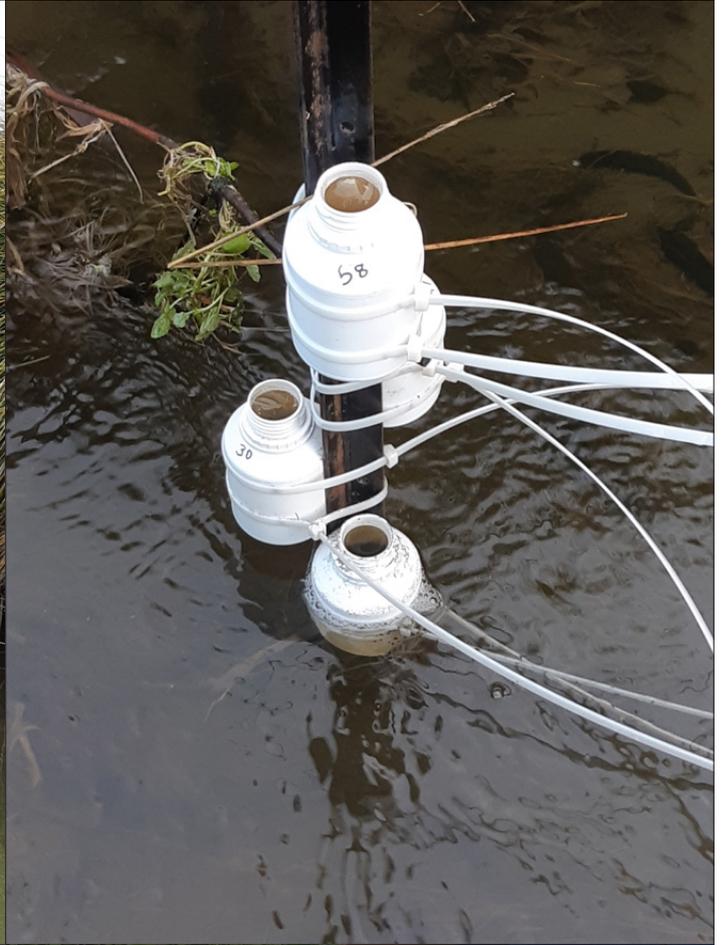
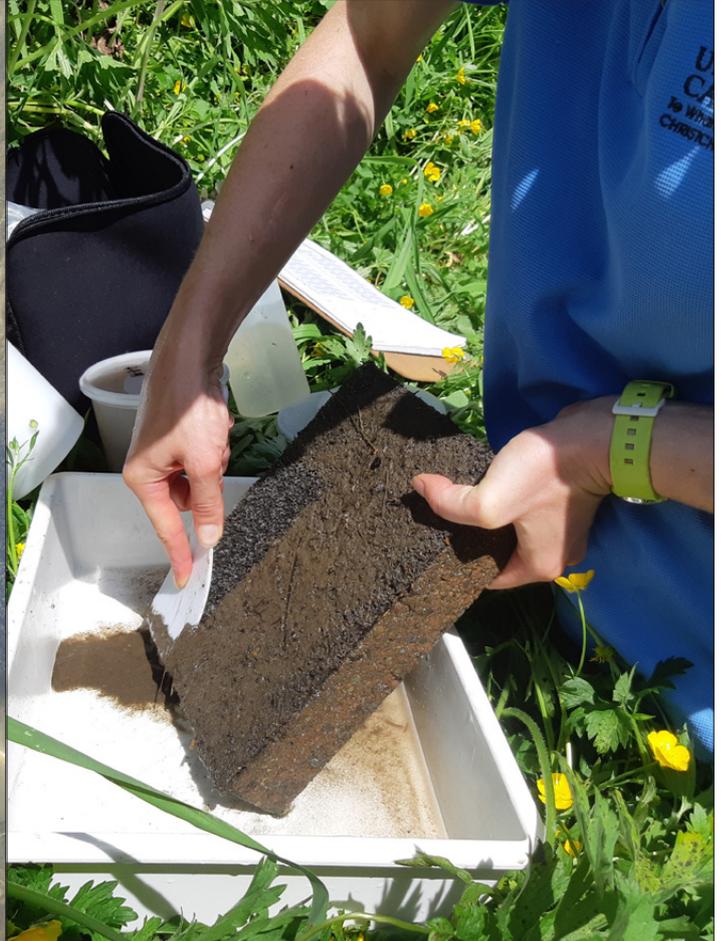
**Figure 6.** Flood (suspended sediment) collectors and bed load sediment tiles

In order to quantify sediment loads and transport more intensive sediment data was collected at five sites and suspended sediment during flood events was collected at 10 sites (Fig. 6).
